# Damage to Steel Buildings after 2011 Tohoku-Oki Earthquake in Japan

December 5, 2016  
Lehigh University

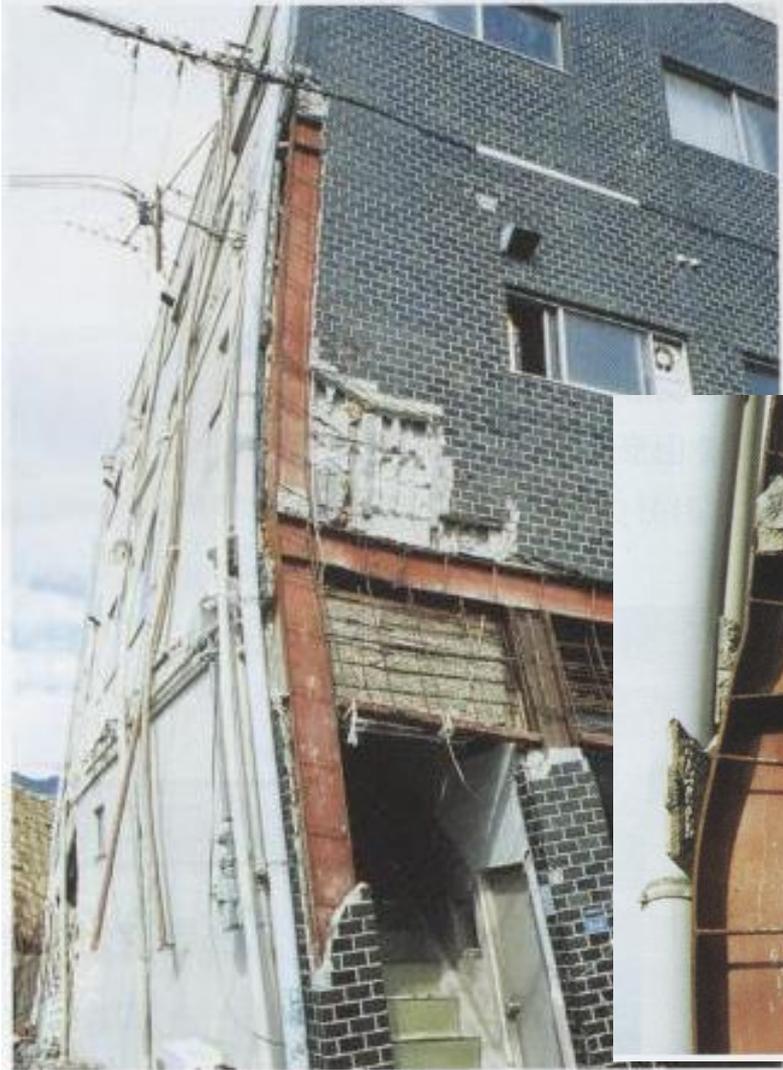
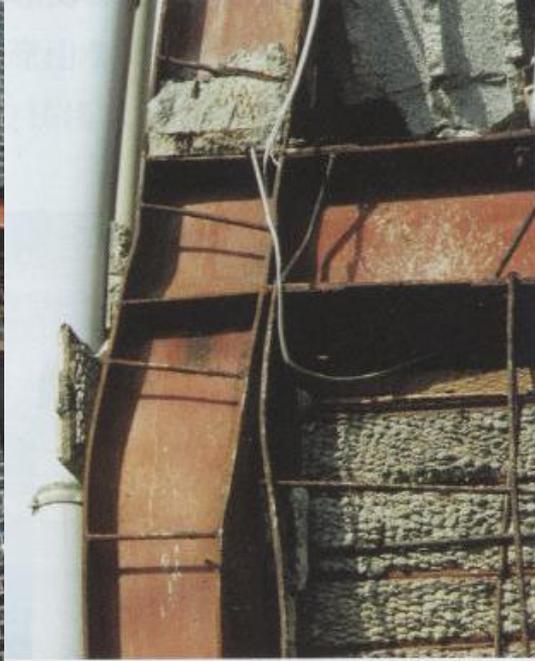
3 story building

H shaped section column

Local buckling of the column flange

Shear distortion of the joint panel

- 1) Lack of the frame strength
- 2) Large width to thickness ratio of member section.
- 3) Lack of the reinforcement of joint panel.

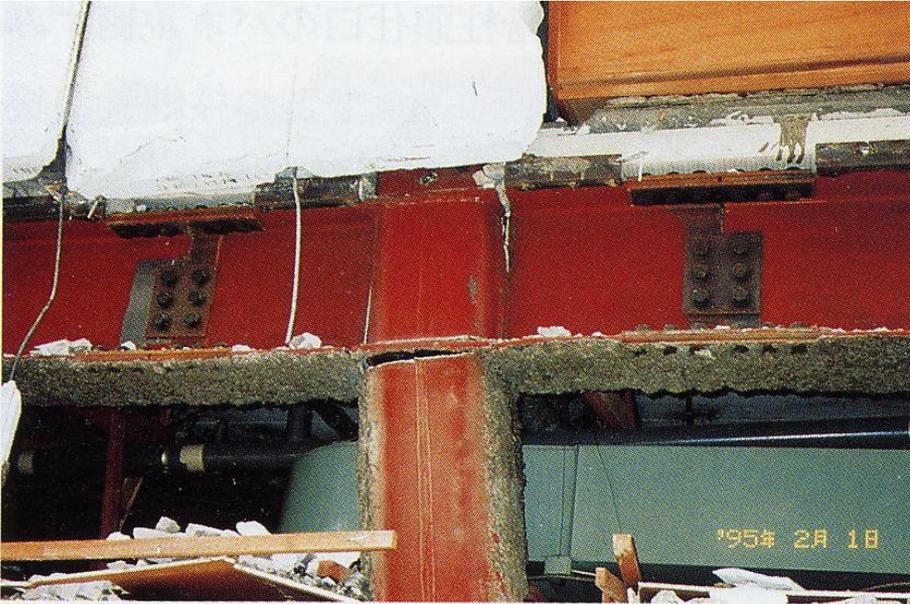
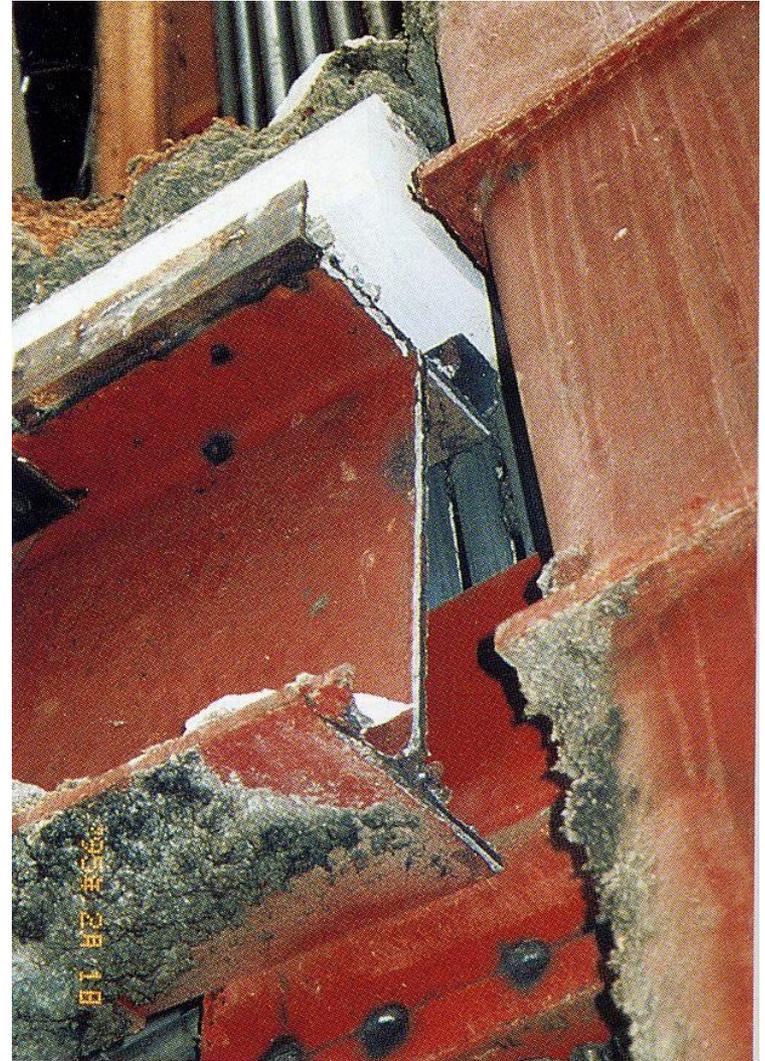
5 story building, Moment  
frame, Box-column section  
Fracture of welds at  
beam-to-column connection

**Inadequate fillet welding**

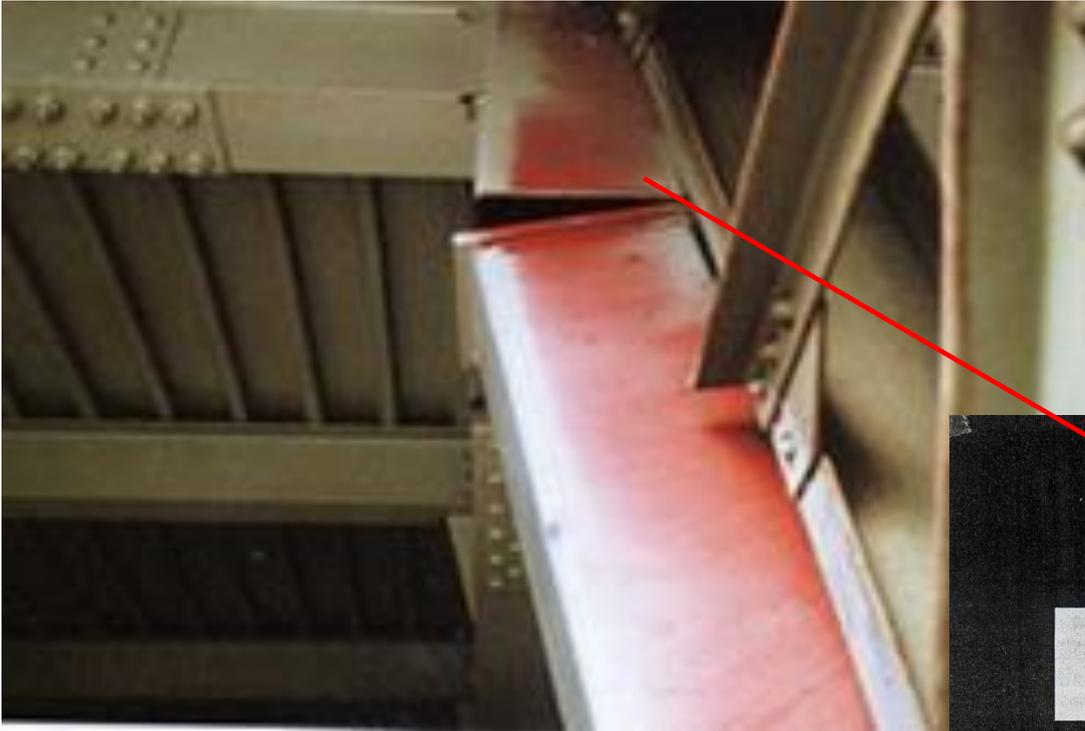
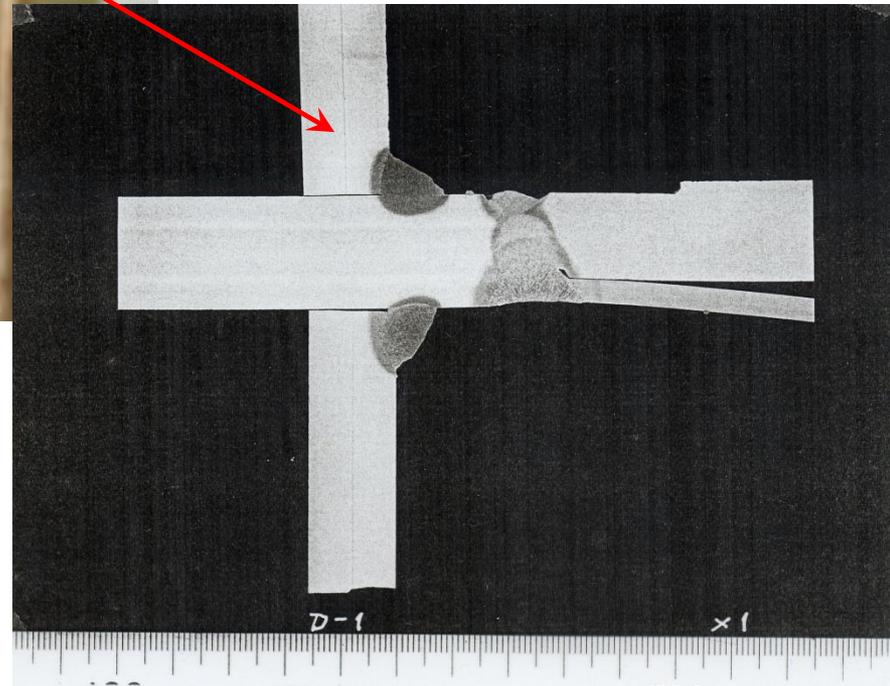
Improper usage  
of fillet welding

Fillet welding at only  
outside of the column

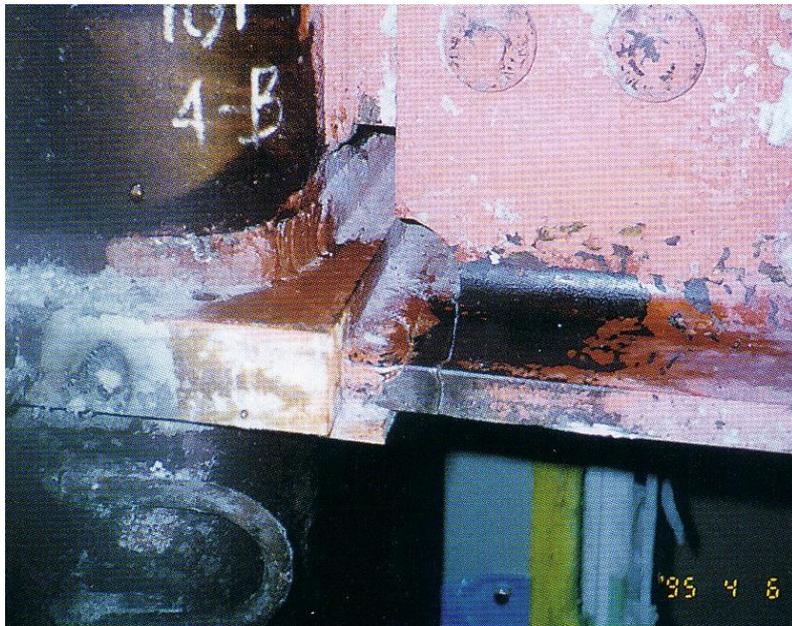
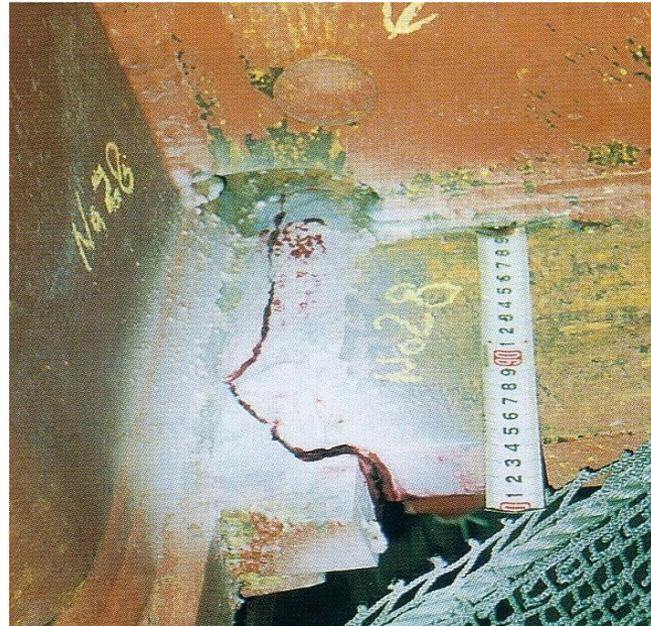
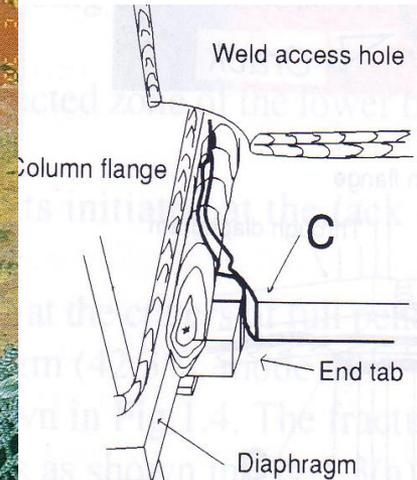
Start from End tab (run-off tub)

Start from Weld access hole (scallop)

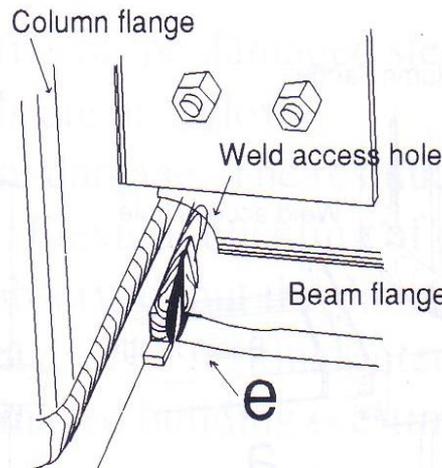
**Brittle fractures around beam-column welding joint**

**(The pre-qualified welded joints is much more susceptible to damage than was previously expected)**

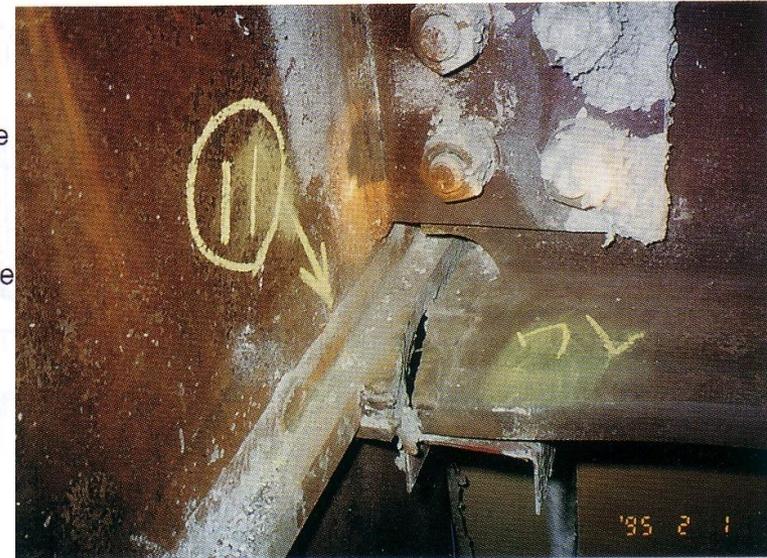
Start from Improper welding crater

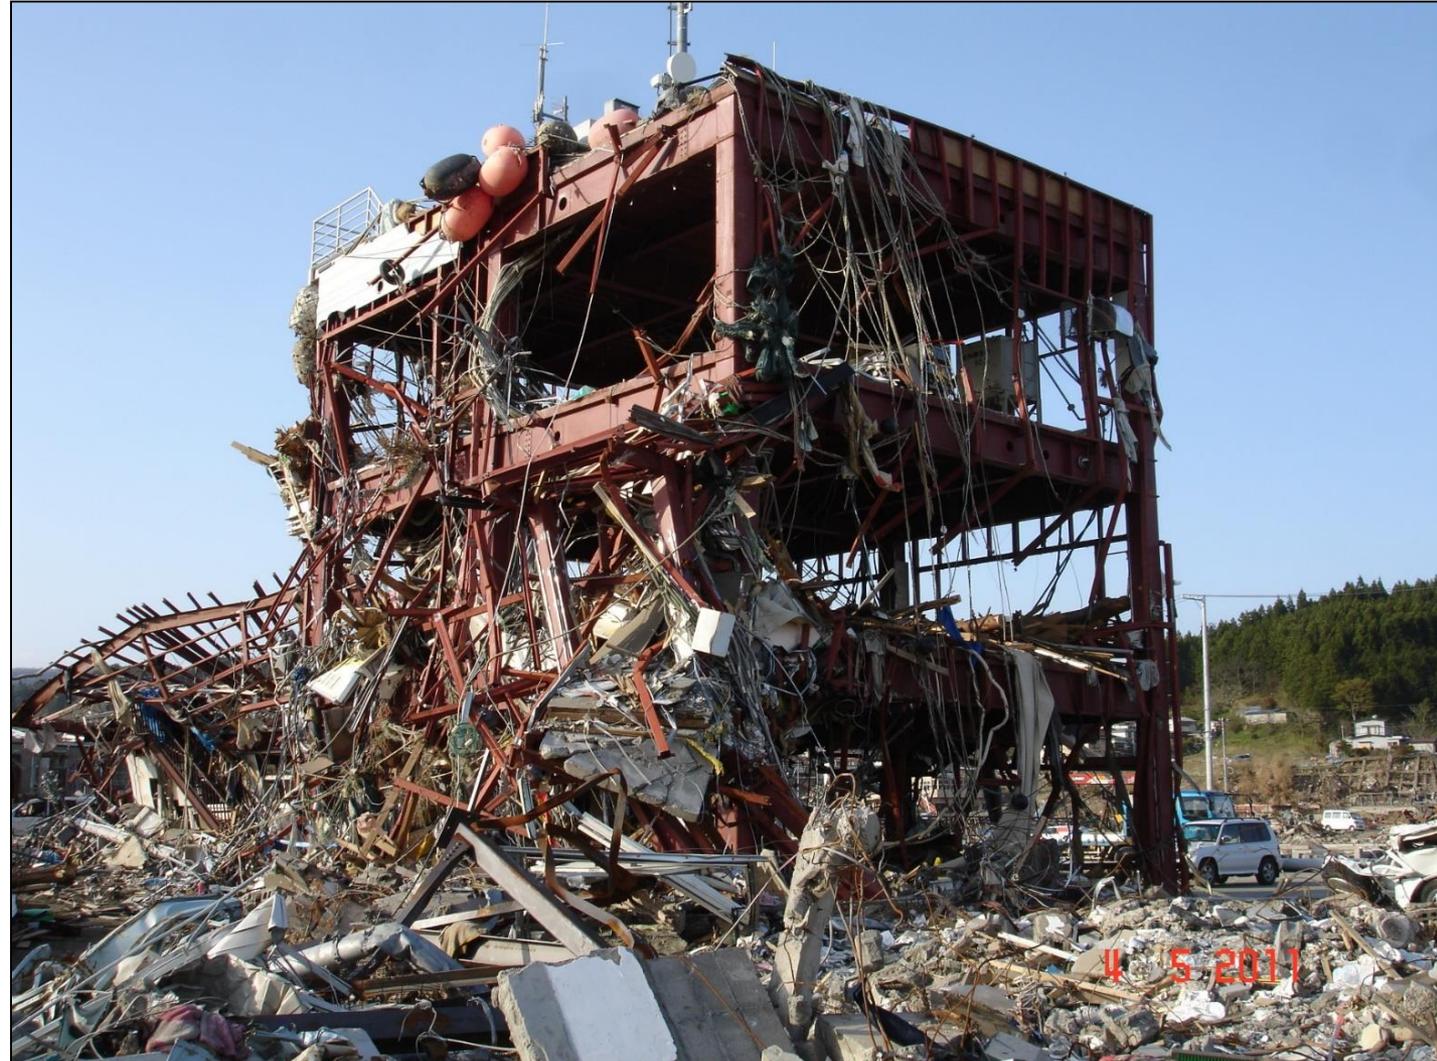
- **Minamisanriku  
Disaster  
Mitigation Steel  
building**
- **One by two-bay,**
- **Three-story MRF**
- **Evidence of  
sever debris  
impact**

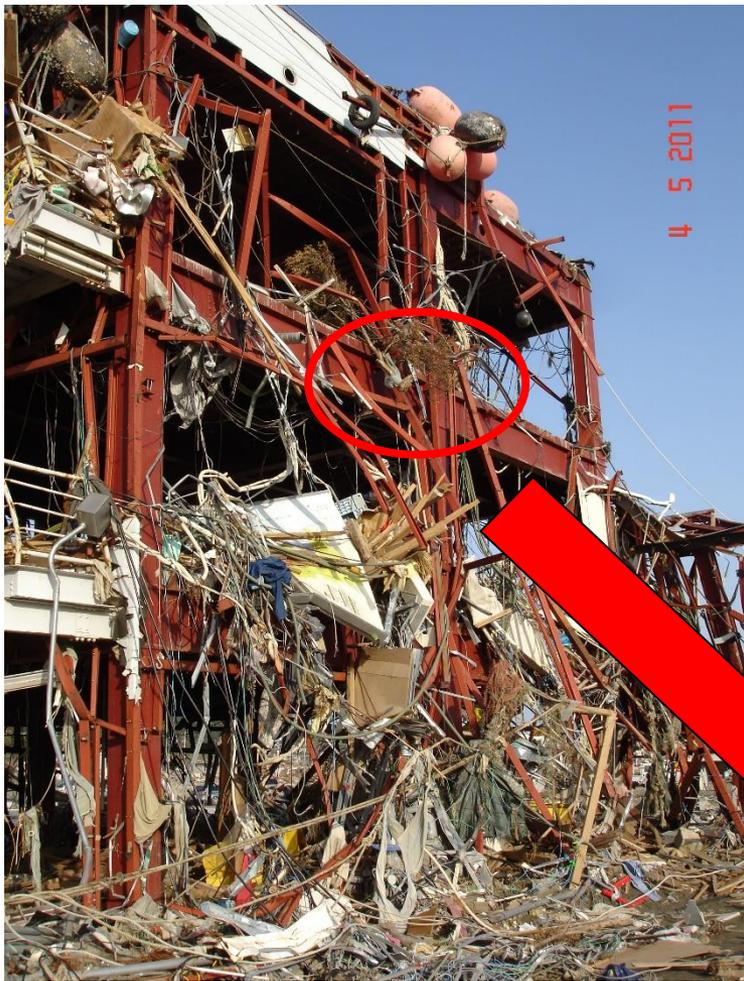
**Steel buildings stood upright after the tsunami subsided. However, in most cases, steel buildings suffered extensive damage to their external and internal finishes along with their contents**

**No structural damage**

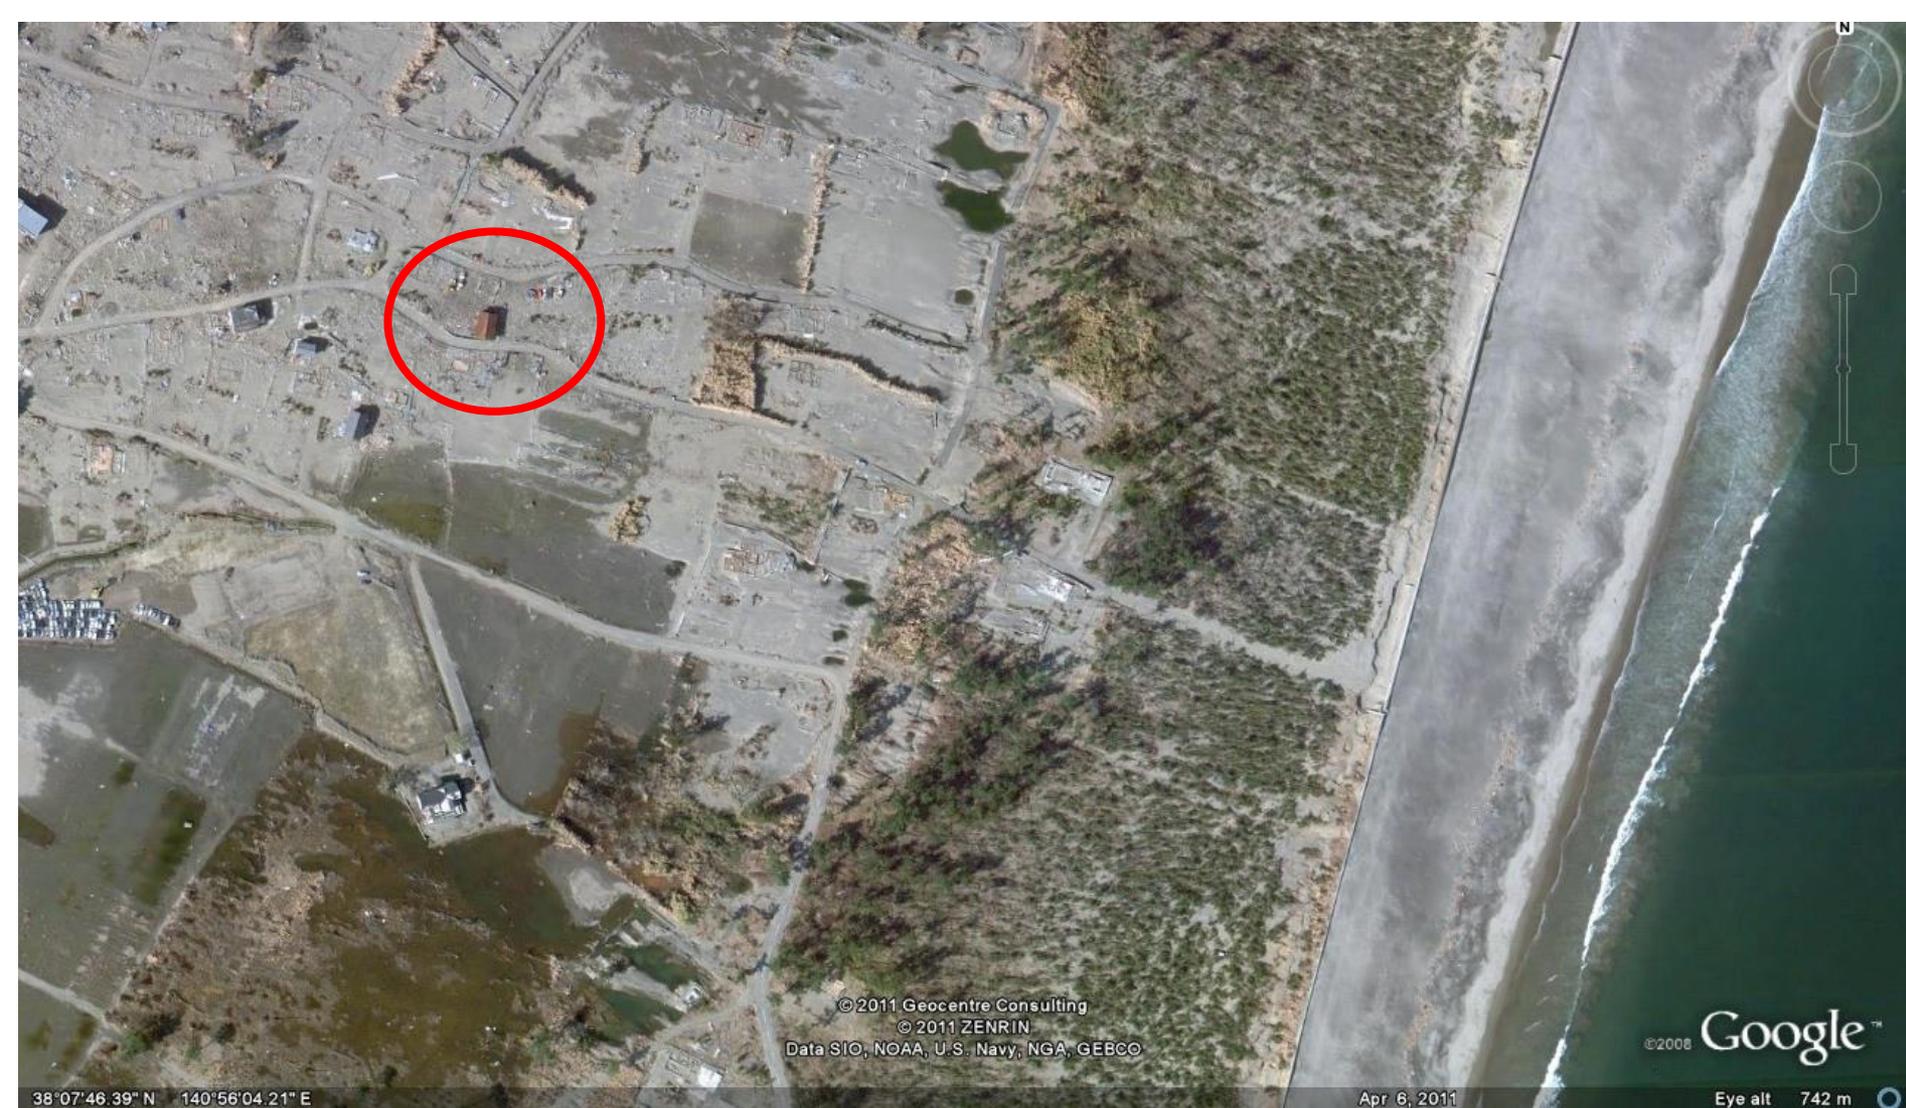
- The area was densely populated with timber residences.
- Almost all of timber residences were completely destroyed by tsunami
- **Jus light-gauge steel residence that stood upright but suffered extensive damage to its exterior and contents**

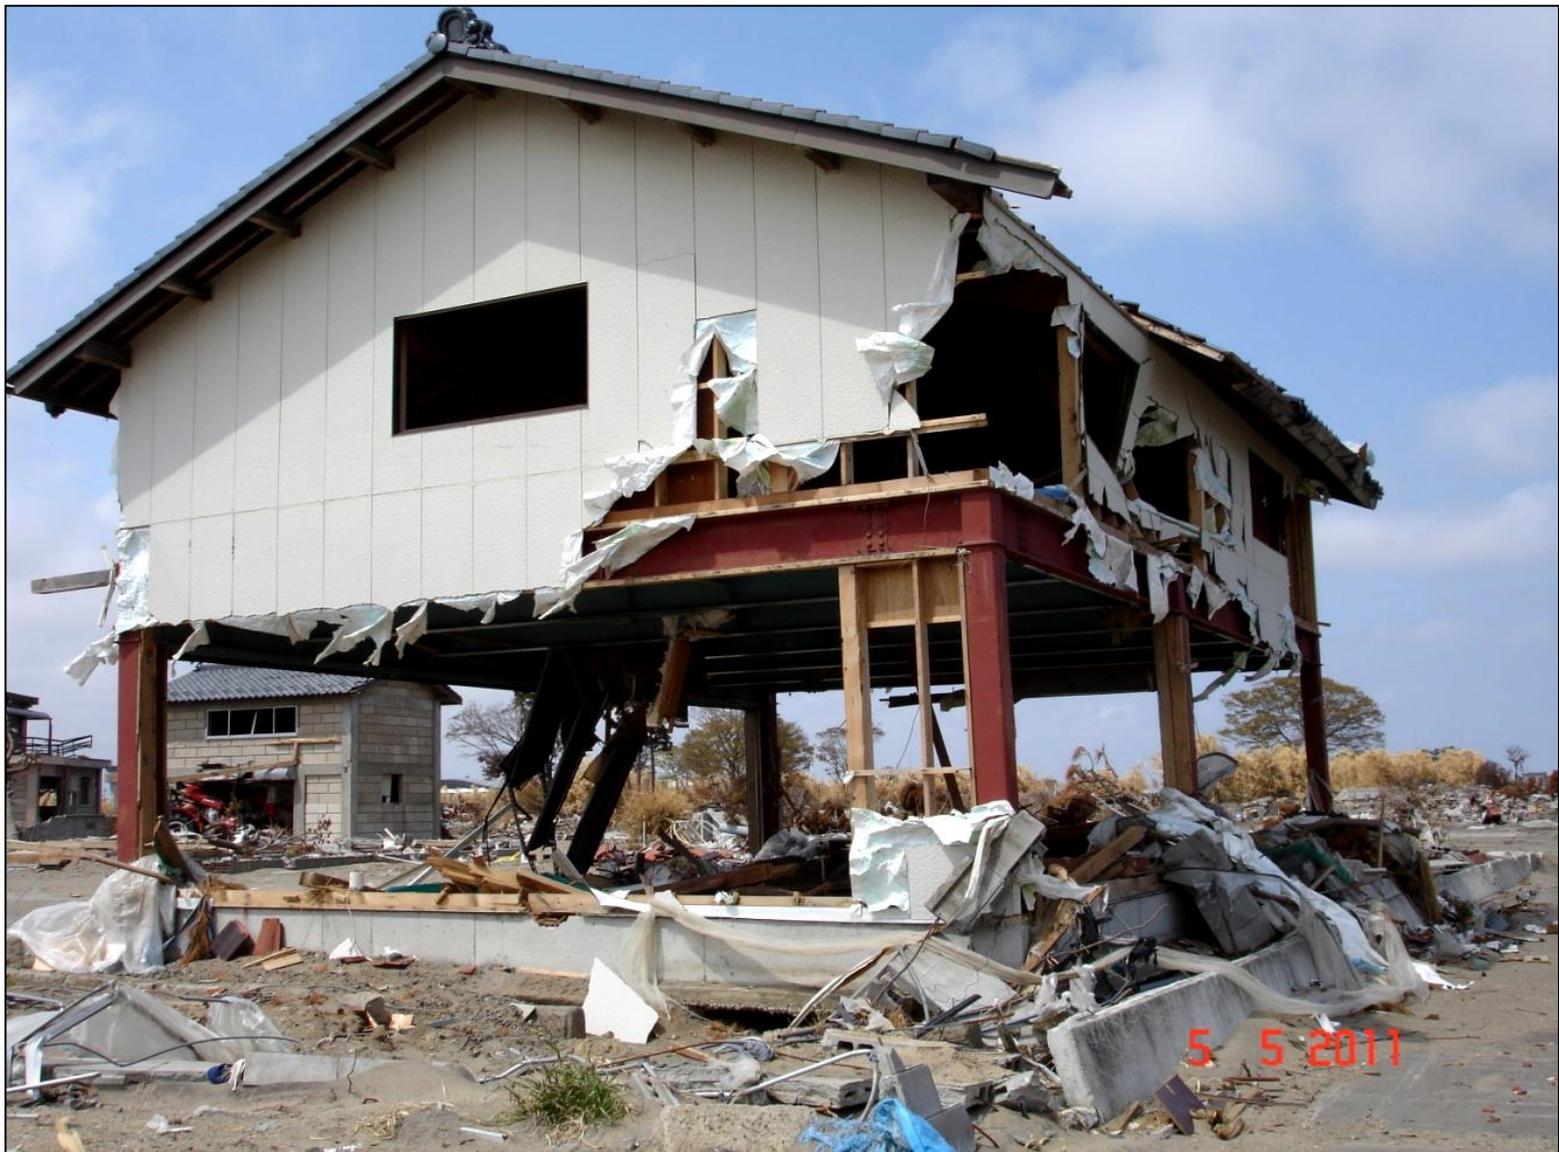
- **Two-story residence constructed with steel in the first story and timber in the upper story**
- **The exterior wall was lost at the first floor**

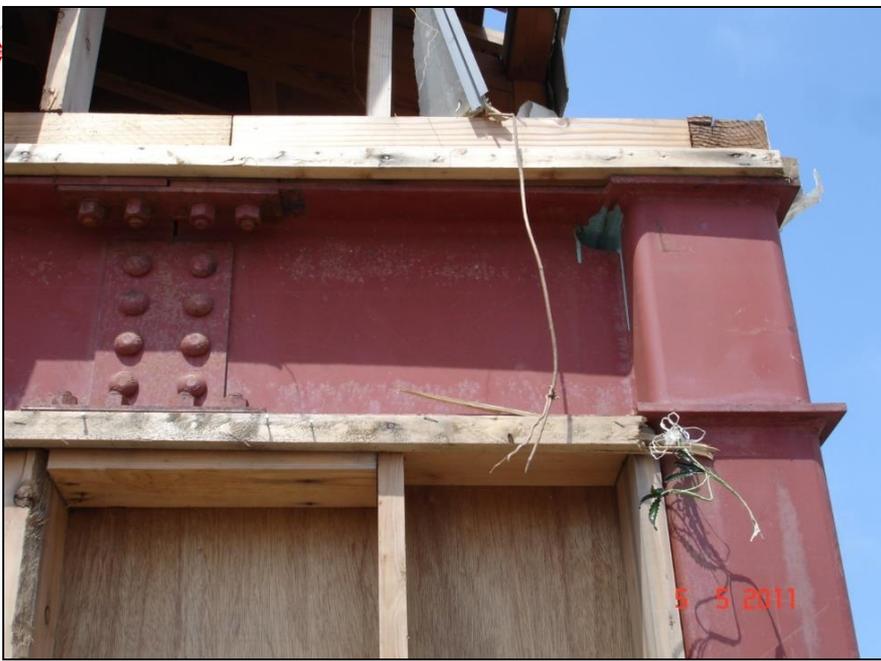
- The external claddings in these structures were easily damaged by tsunami
- It is suspected that the early loss of claddings, alleviated the immense lateral load that the tsunami pressure otherwise would have delivered

**No structural damage in the steel frame**

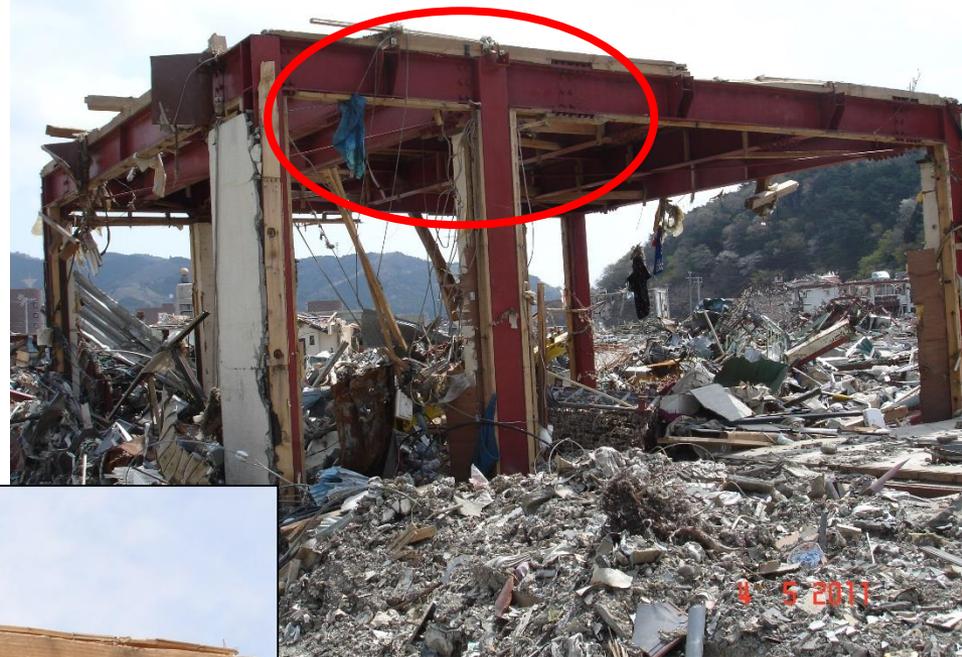
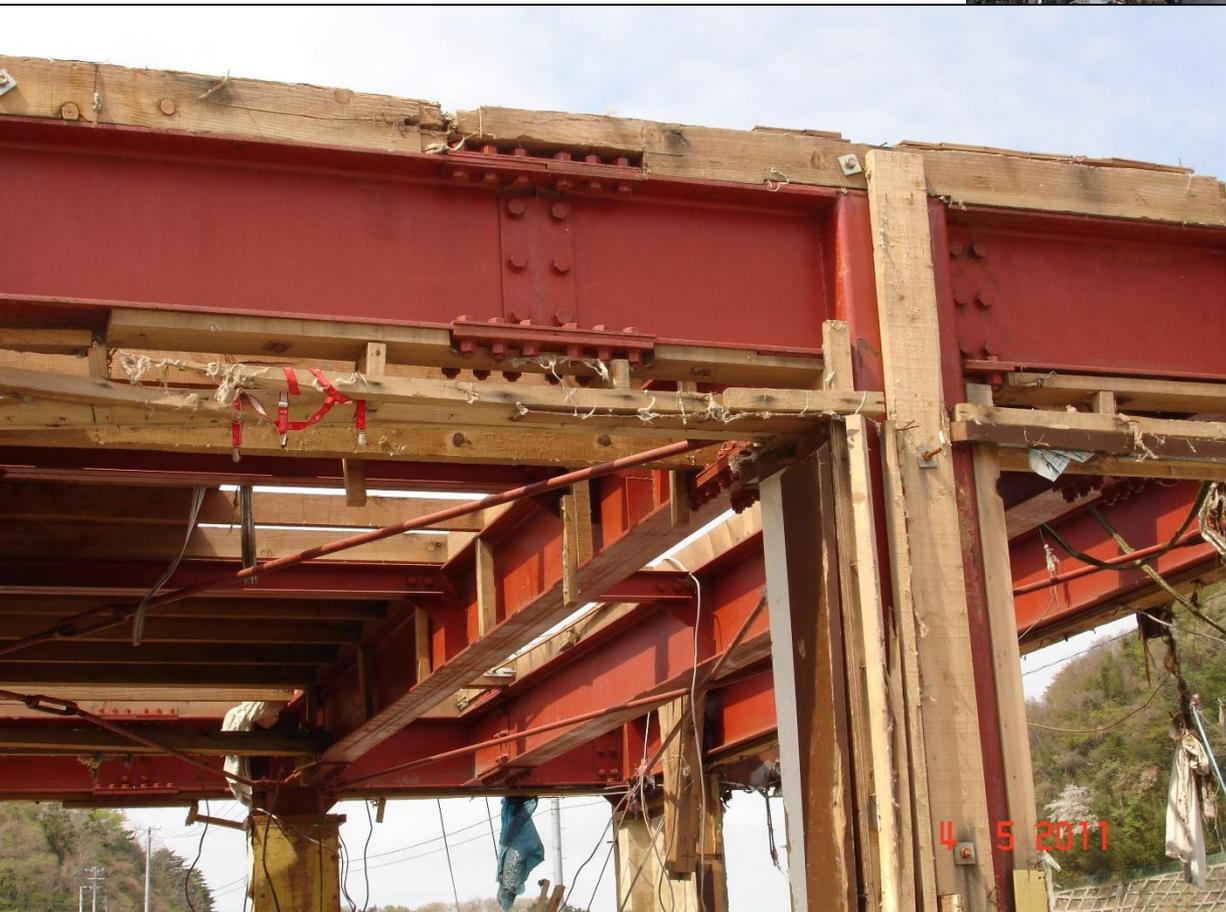
- Two-story residence constructed with steel in the first story and timber in the upper story
- The upper timber story and exterior wall of first story was lost

**No structural  
damage in the steel  
frame**

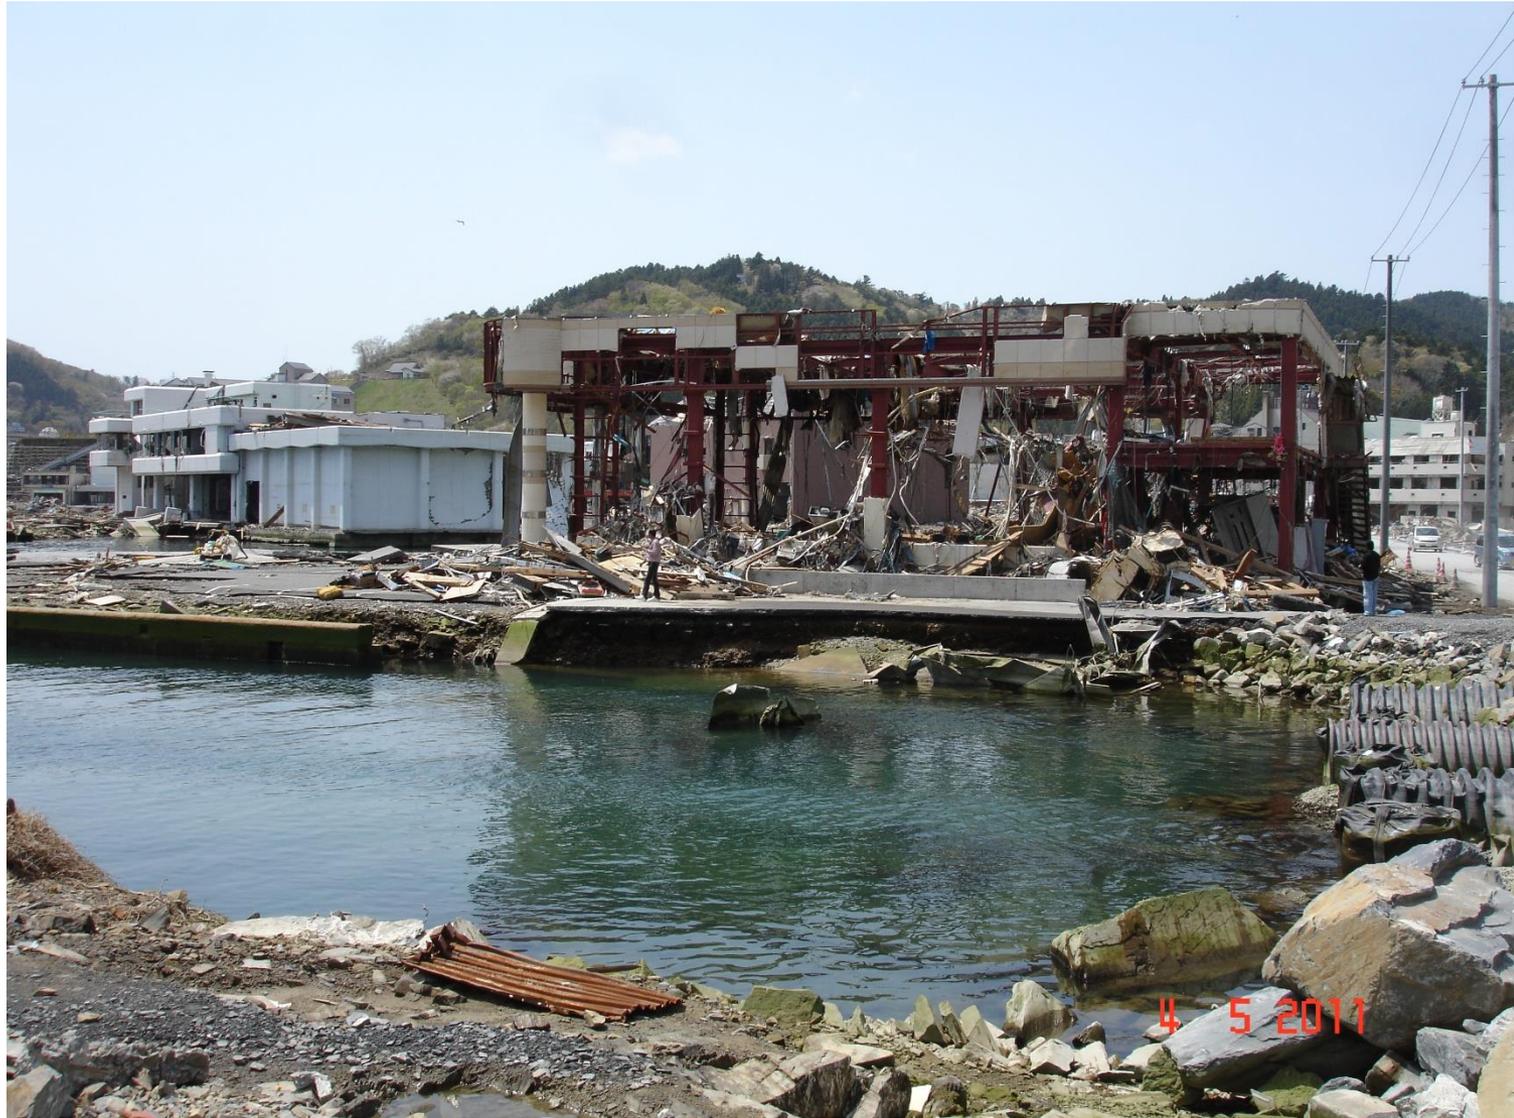
**Steel structure just near by the coast of Onagawa**

The exterior wall was lost;  
Steel structure could withstand large tsunami forces

**The strength of the column base seemed to play a key role in collapse prevention against the tsunami**
