# **Cast-in-Place RC Coupled Shear Walls: *Unbonded Post-Tensioned Coupling Beams & Debonded Starter Bars at Wall Base***

**Yahya C. Kurama, Ph.D., P.E.  
Steven M. Barbachyn, M.S.  
University of Notre Dame**

**NHERI Lehigh Researcher's Workshop  
Bethlehem, PA  
December 5-6, 2016**

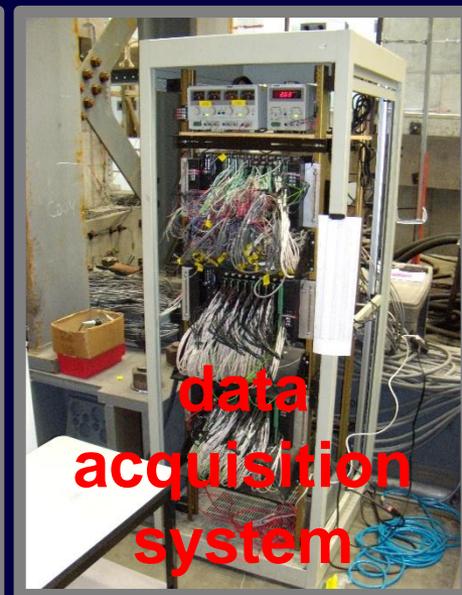
# Instrumentation

Type	Specimen 1	Specimen 2
load cells	29	29
displacement	123	156
rotation	46	46
strain gauges	214	250
<b>TOTAL</b>	<b>412</b>	<b>481</b>

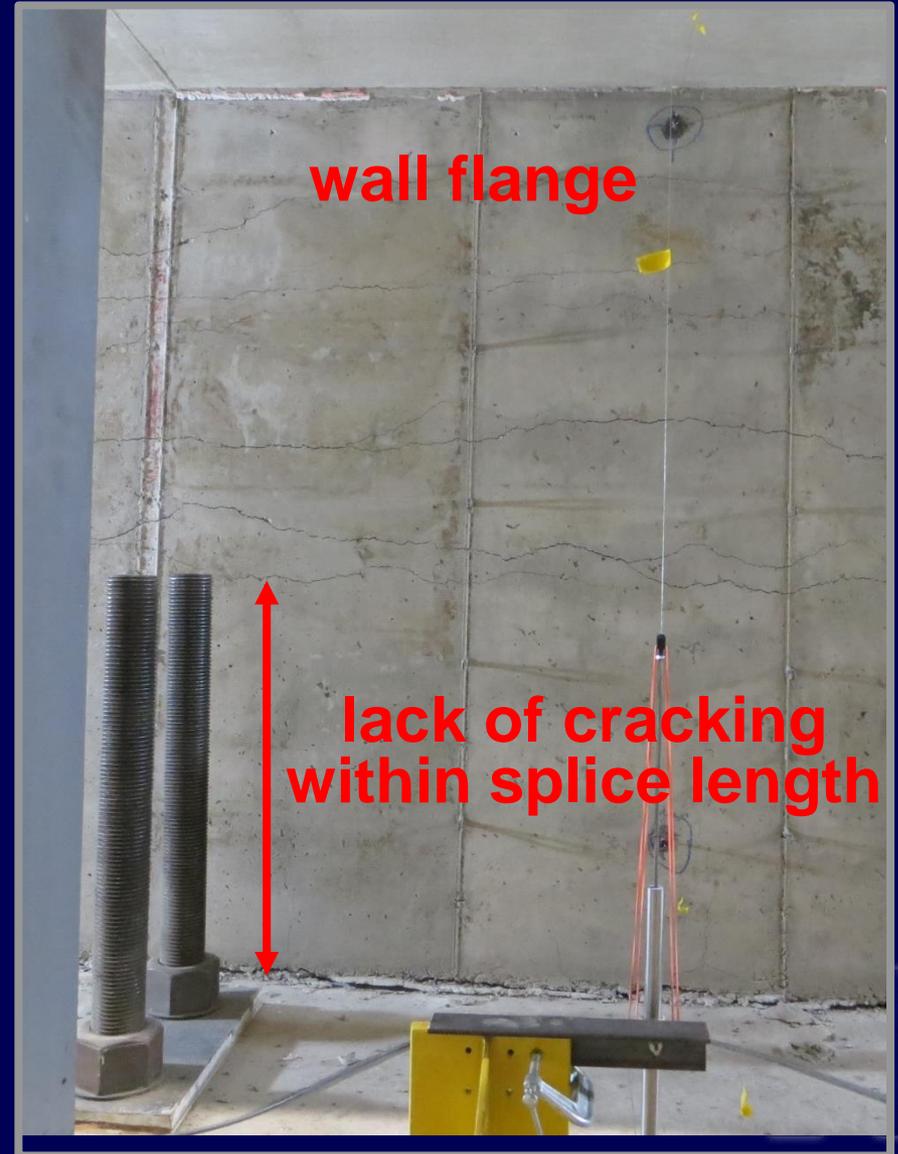
# Reasons for Starter Bar Fracture

## 1. Lap splices above foundation

- Lap splices of vertical starter bars above foundation resulted in concentration of cracking at wall base (with little distributed cracking within spliced wall height)
- There was also significant deterioration to concrete at top of foundation
- Failure in Specimen 1 occurred due to buckling and subsequent fracture of starter bars in wall pier toes
- Unbonding of starter bars in toes improved behavior of Specimen 2 by delaying buckling/fracture of starter bars
- General recommendation for RC shear walls:
  - consider lack of cracking over splice length of starter bars
  - unbonding of starter bars may delay bar fracture

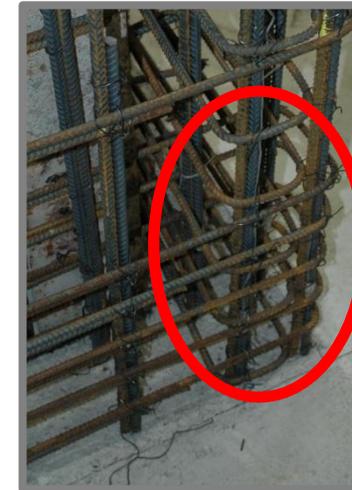
**Specimen 2**

# Detail Change in Wall Pier Corners

**closely-spaced U-bars**
