# Damage to Steel Buildings after 2011 Tohoku-Oki Earthquake in Japan

December 5, 2016  
Lehigh University

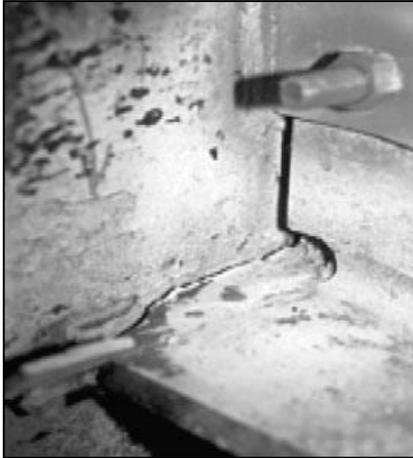
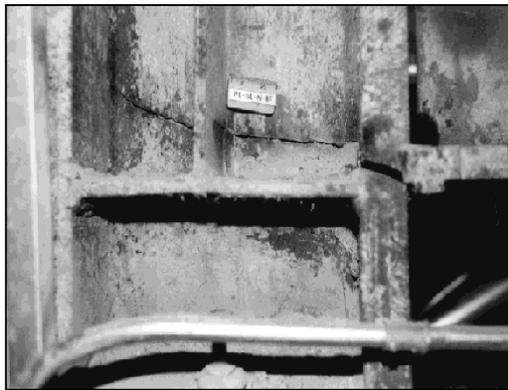
### Brittle Fracture of Connections

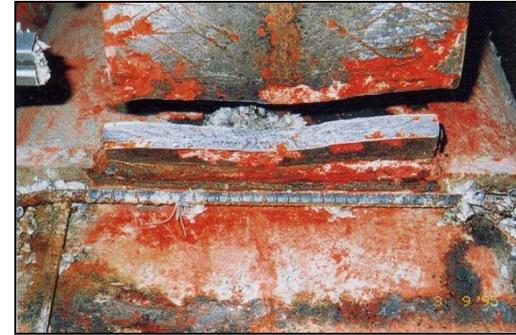
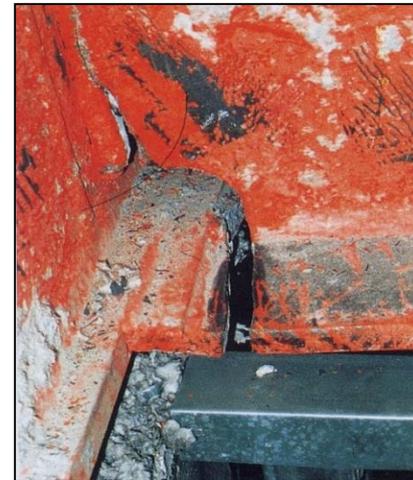
### Damages to Connections

a number of steel moment frame buildings were found to have experienced fracture at connections. In most of cases fractures happened at bottom flange

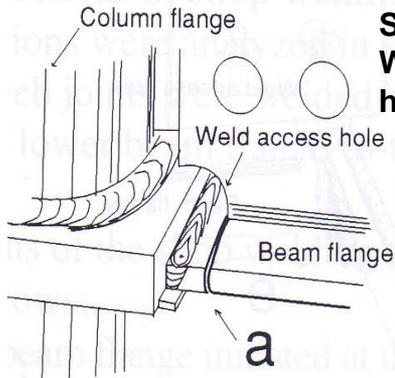
Start from End tab (run-off tub)

**Brittle fractures around beam-column welding joint**

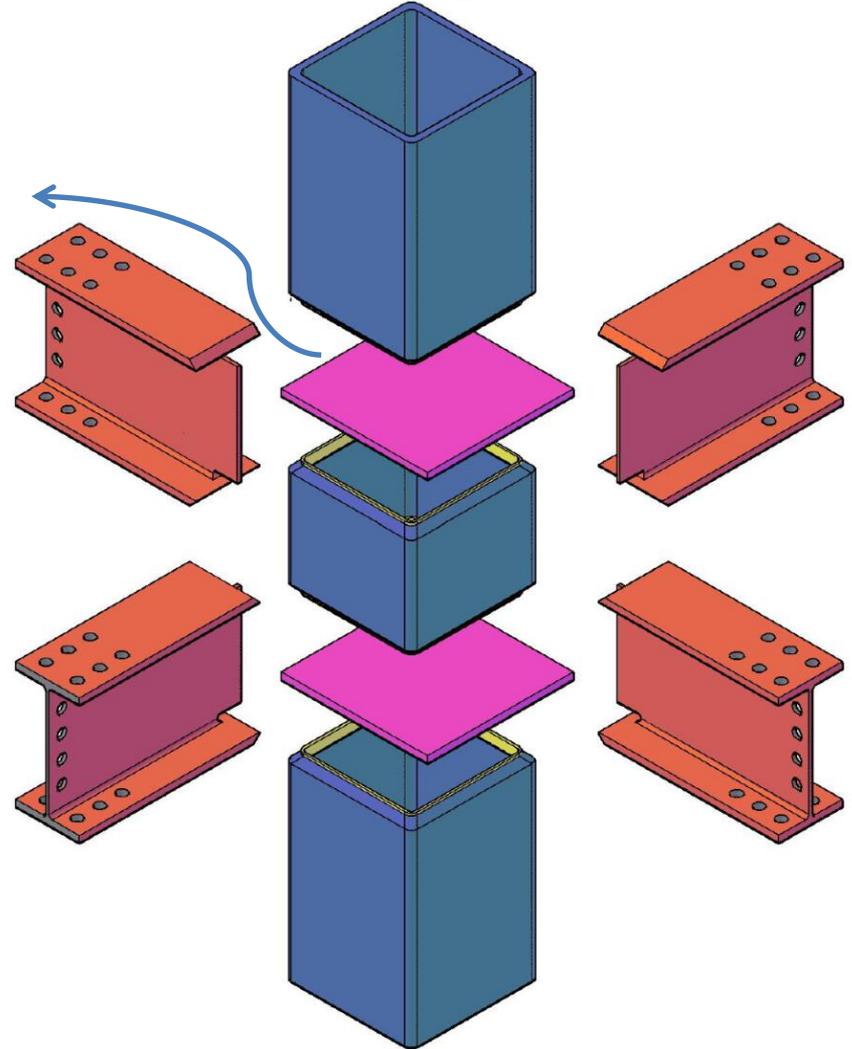
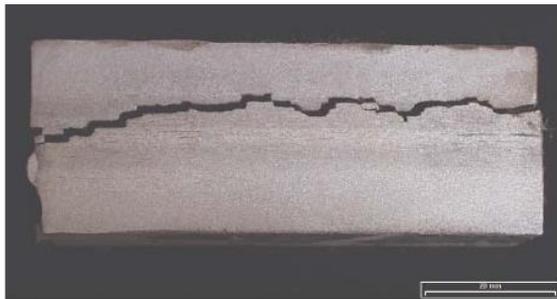
Weld joint configuration increases the risk of lamellar tearing

Lamellar tearing

Control of sulfur content in production of material

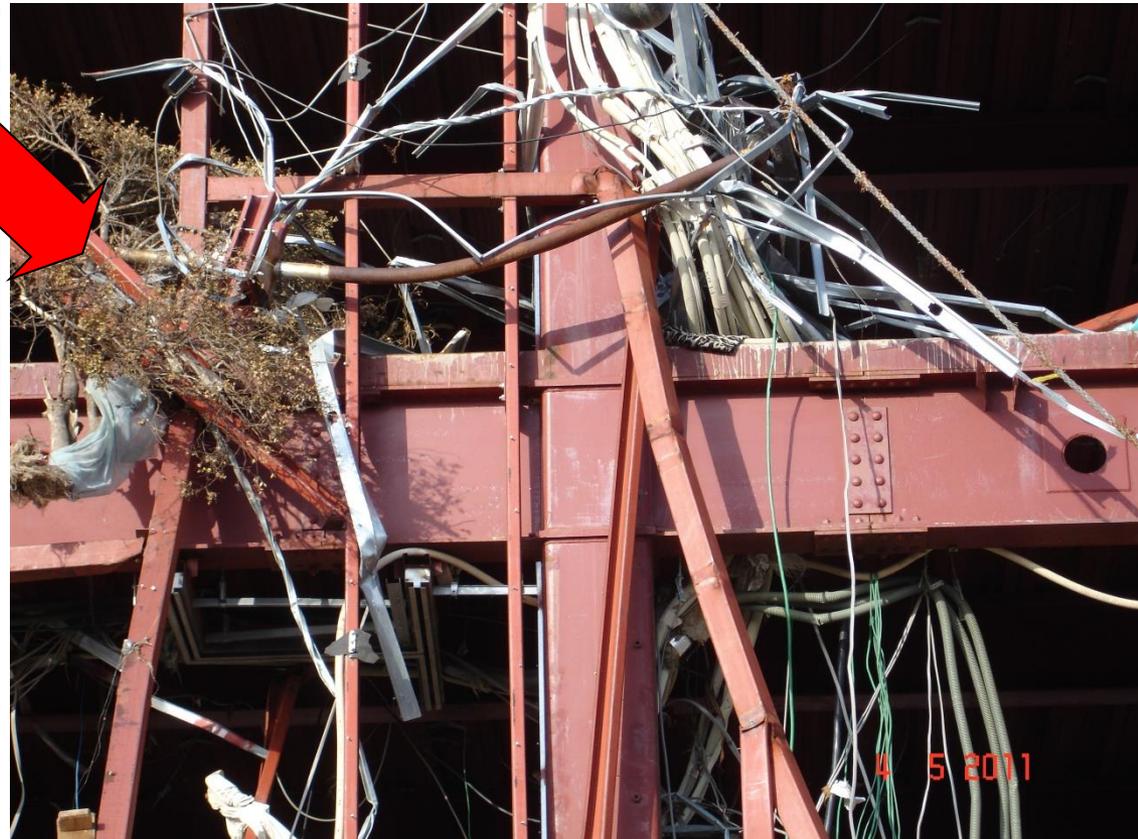
- **Minamisanriku  
Disaster  
Mitigation Steel  
building**
- **One by two-bay,**
- **Three-story MRF**
- **Evidence of  
sever debris  
impact**

**Steel buildings stood upright after the tsunami subsided. However, in most cases, steel buildings suffered extensive damage to their external and internal finishes along with their contents**

**No structural damage**

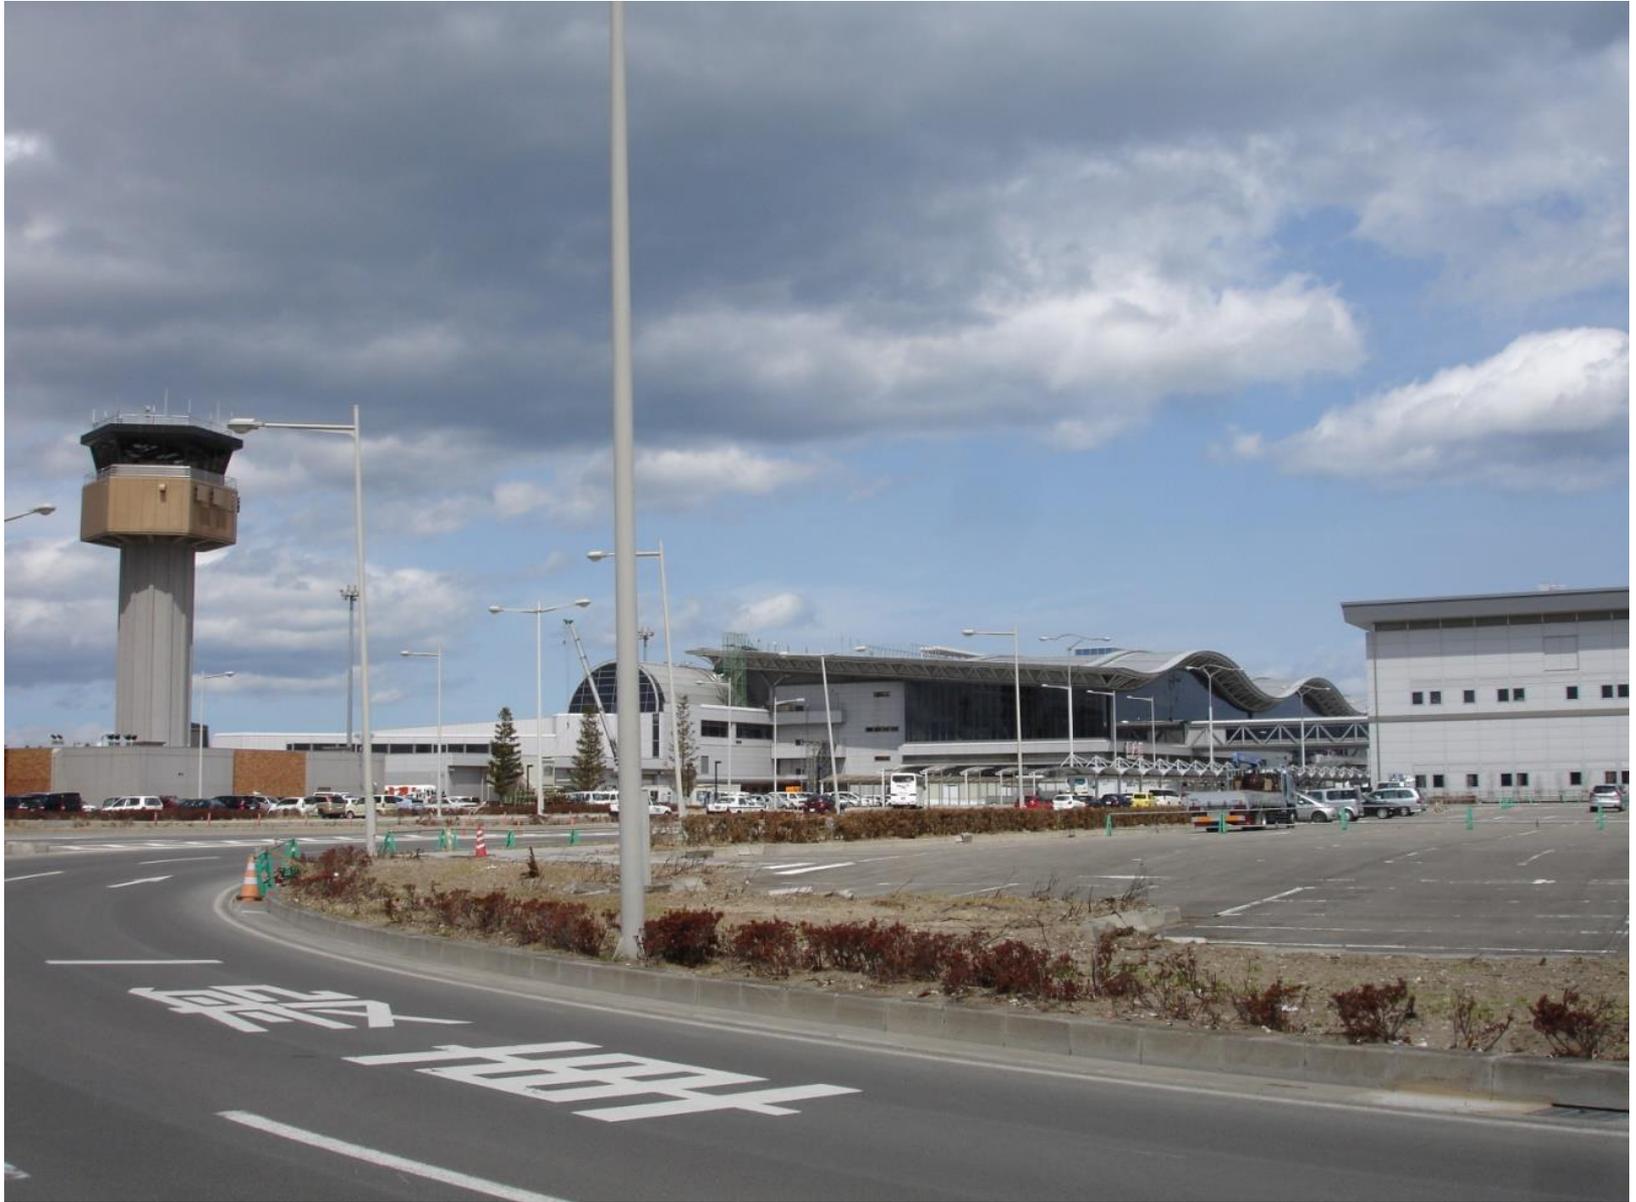
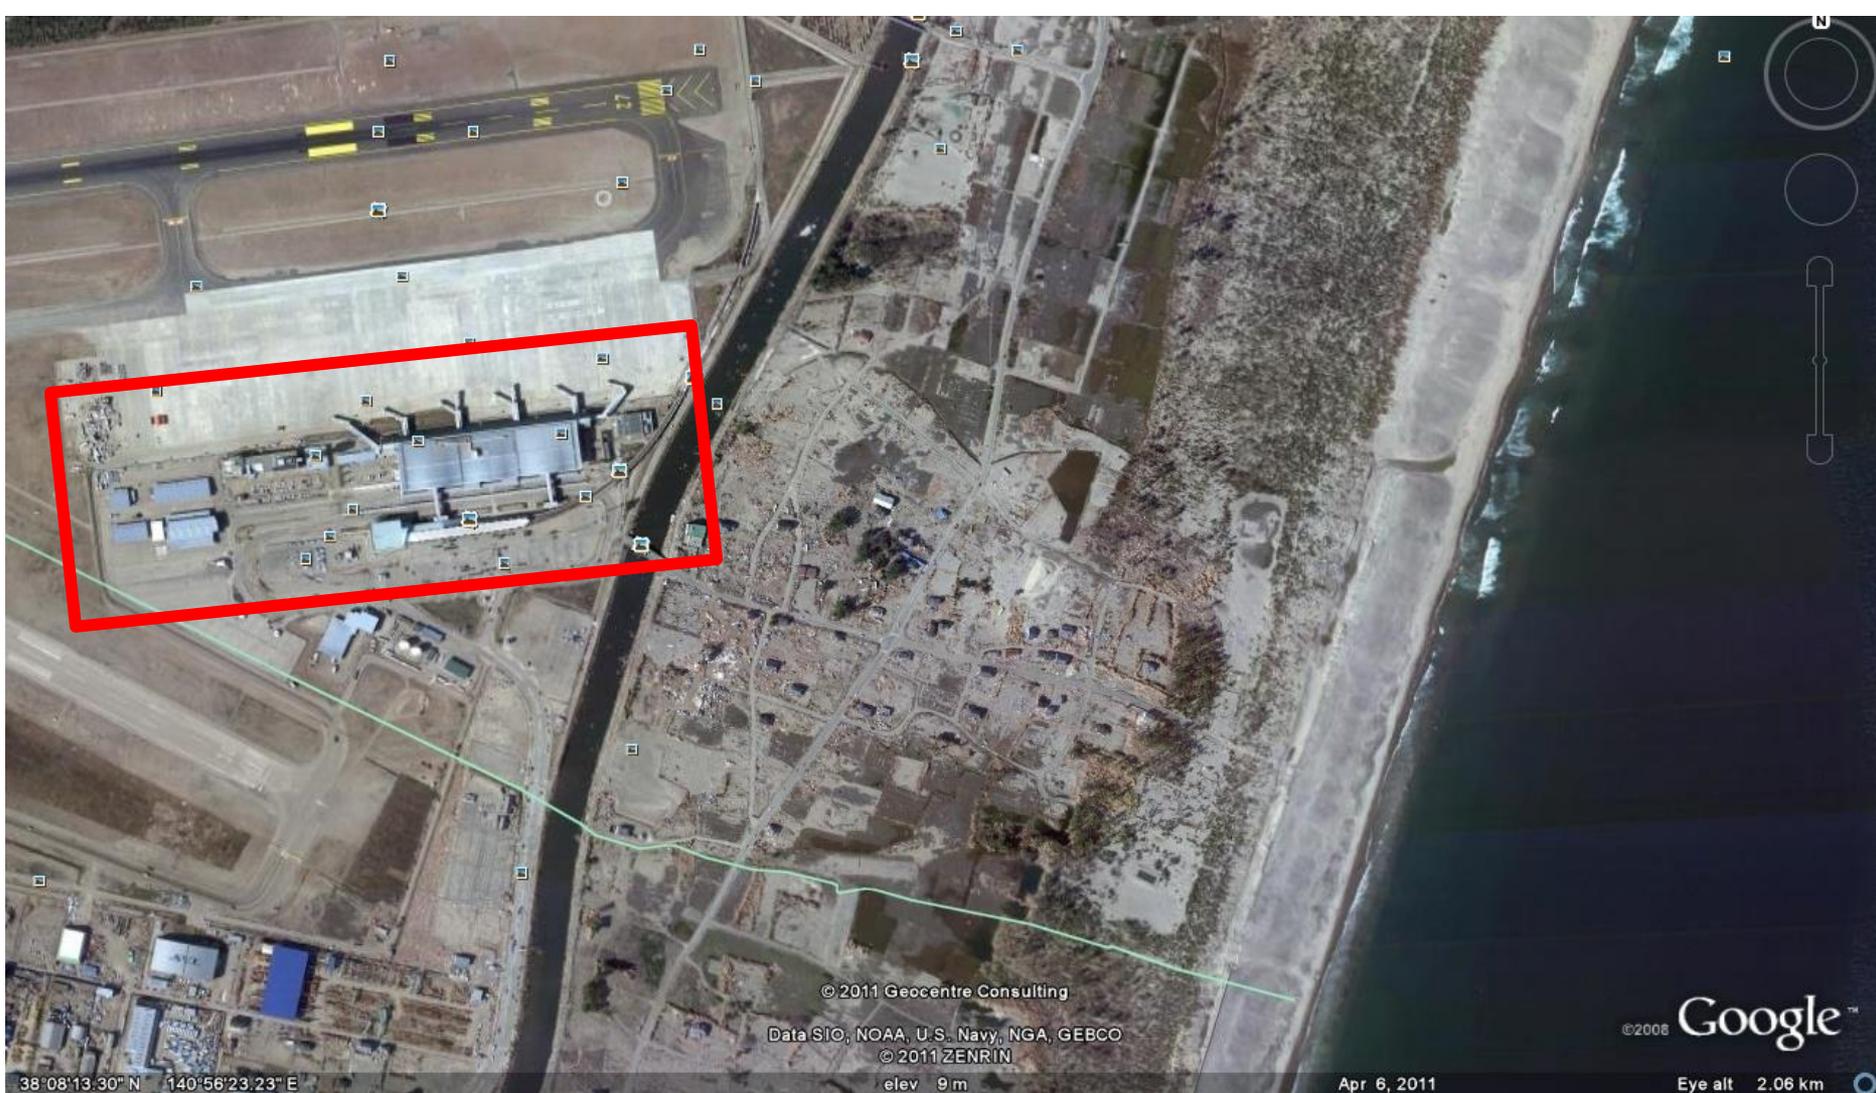
- Residential area between airport and shoreline was completely destroyed by tsunami
- Due to failure of seawall, tsunami attacked Sendai airport 1000 m from the shore.

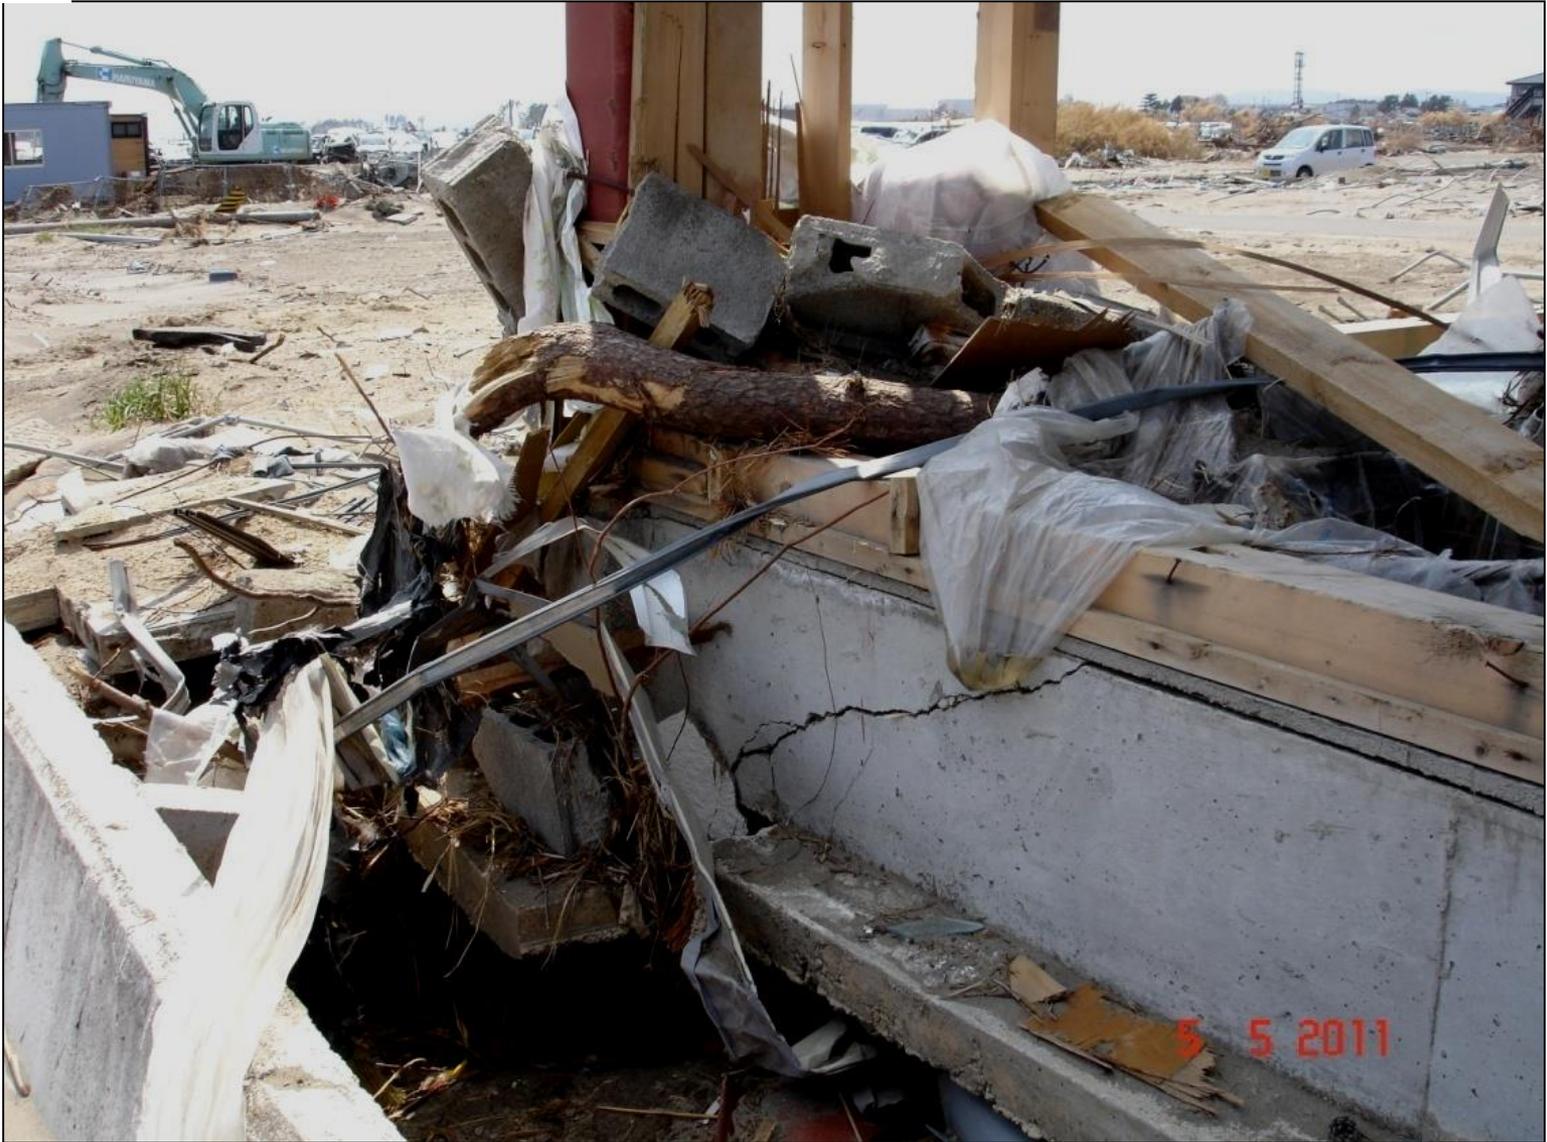
- **Two-story residence constructed with steel in the first story and timber in the upper story**
- **The exterior wall was lost at the first floor**

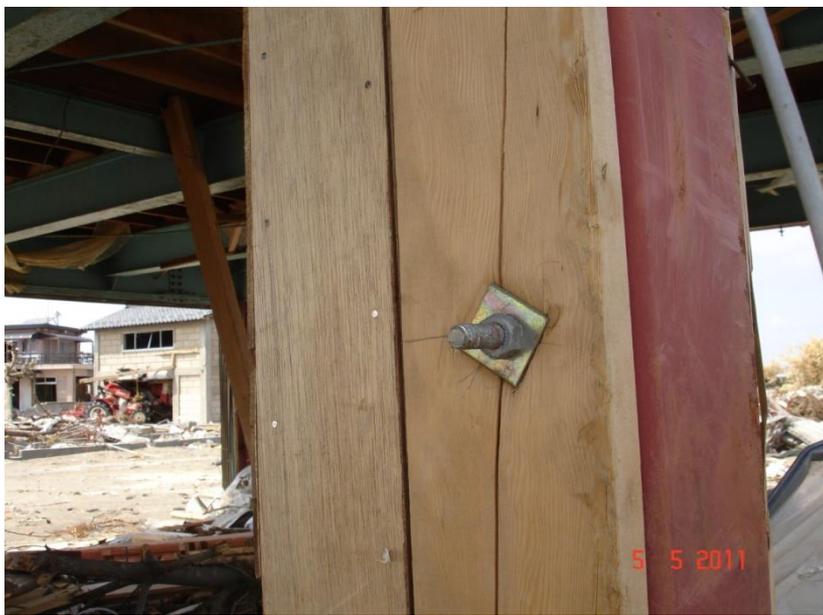
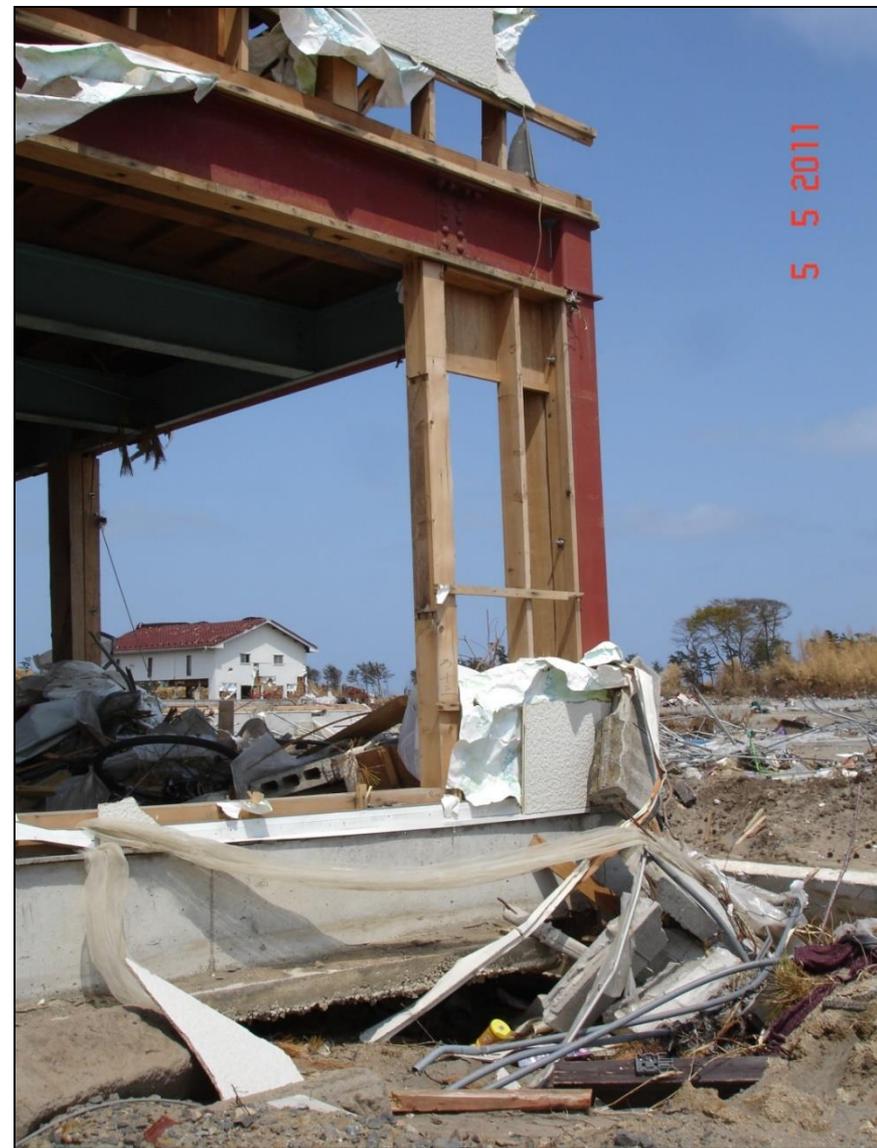
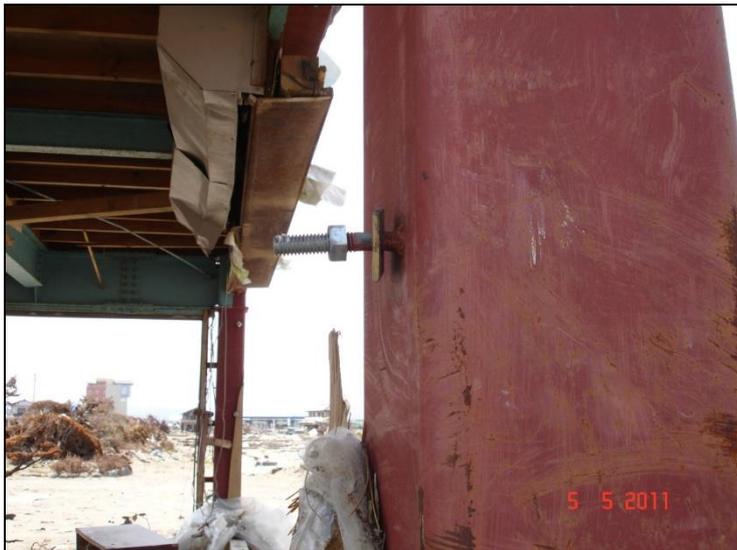
- The external claddings in these structures were easily damaged by tsunami
- It is suspected that the early loss of claddings, alleviated the immense lateral load that the tsunami pressure otherwise would have delivered

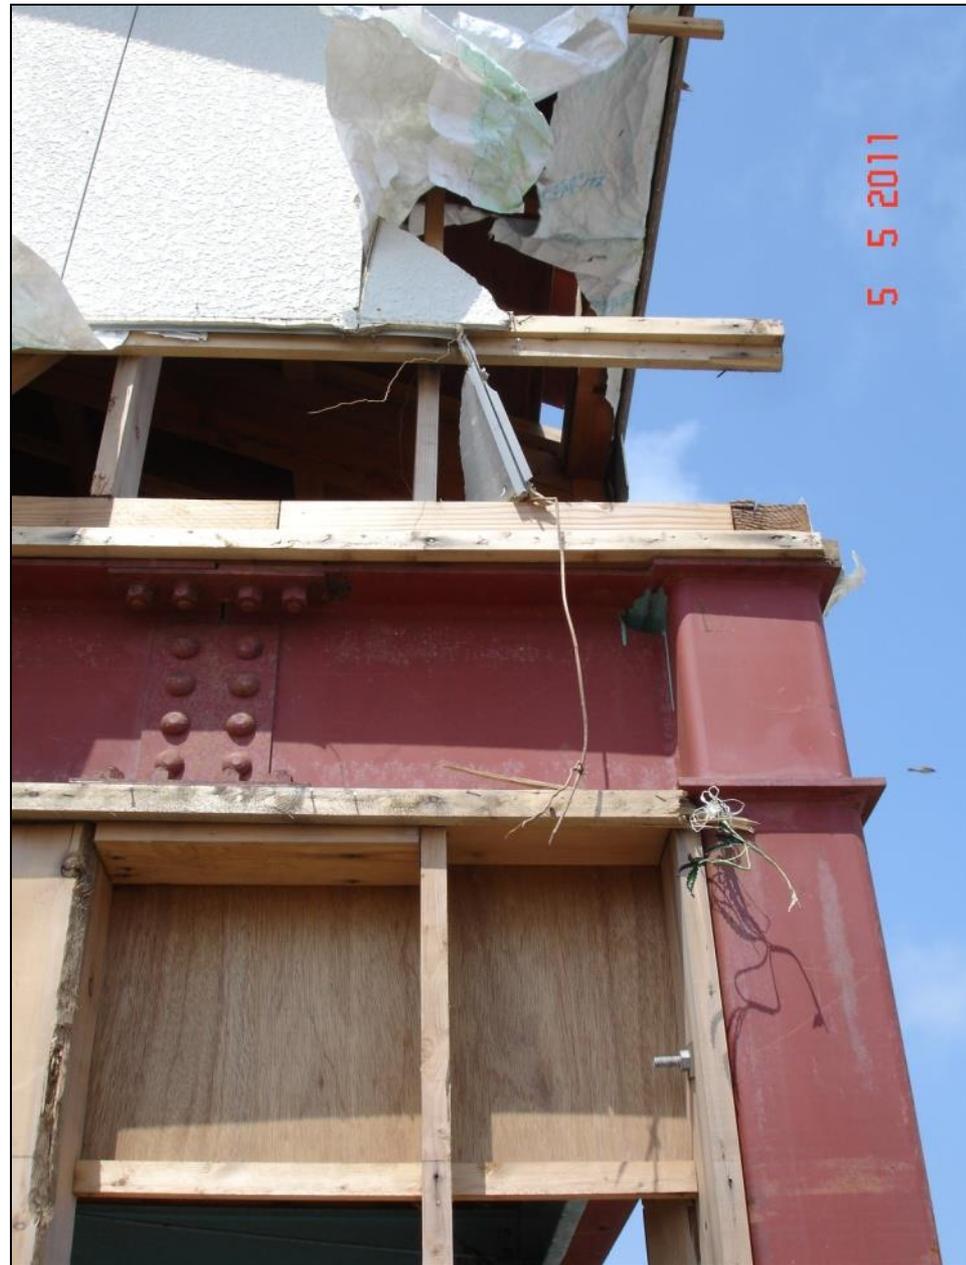
**No structural damage in the steel frame**

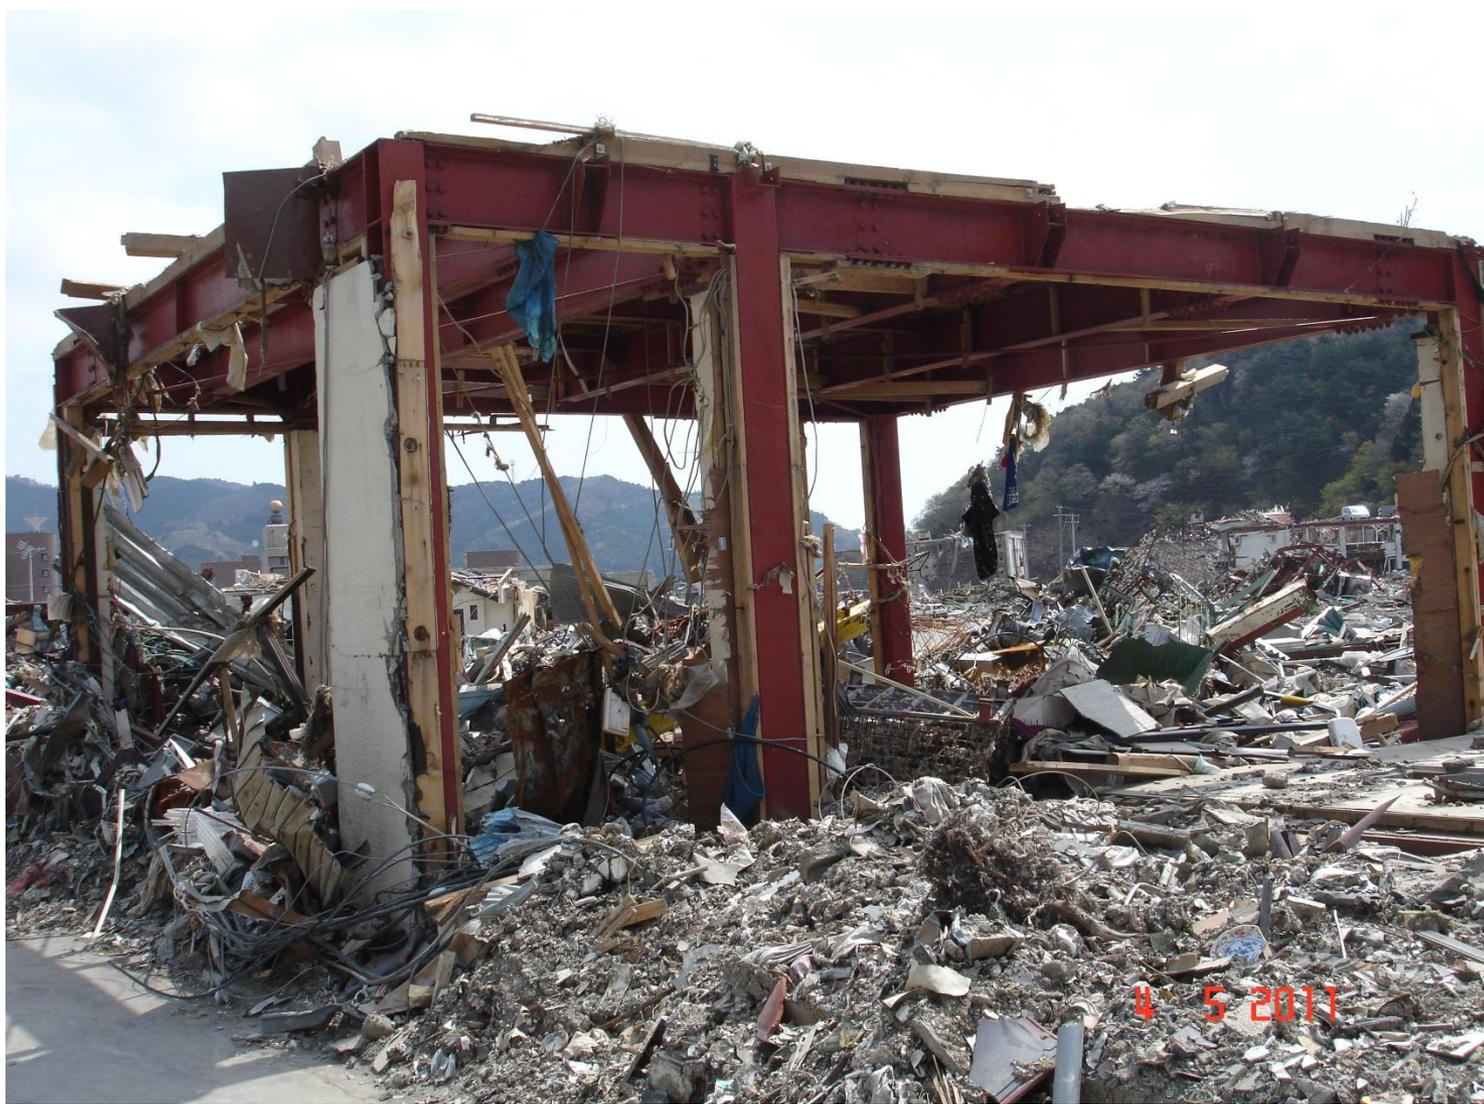
- Two-story residence constructed with steel in the first story and timber in the upper story
- The upper timber story and exterior wall of first story was lost

**No structural  
damage in the steel  
frame**

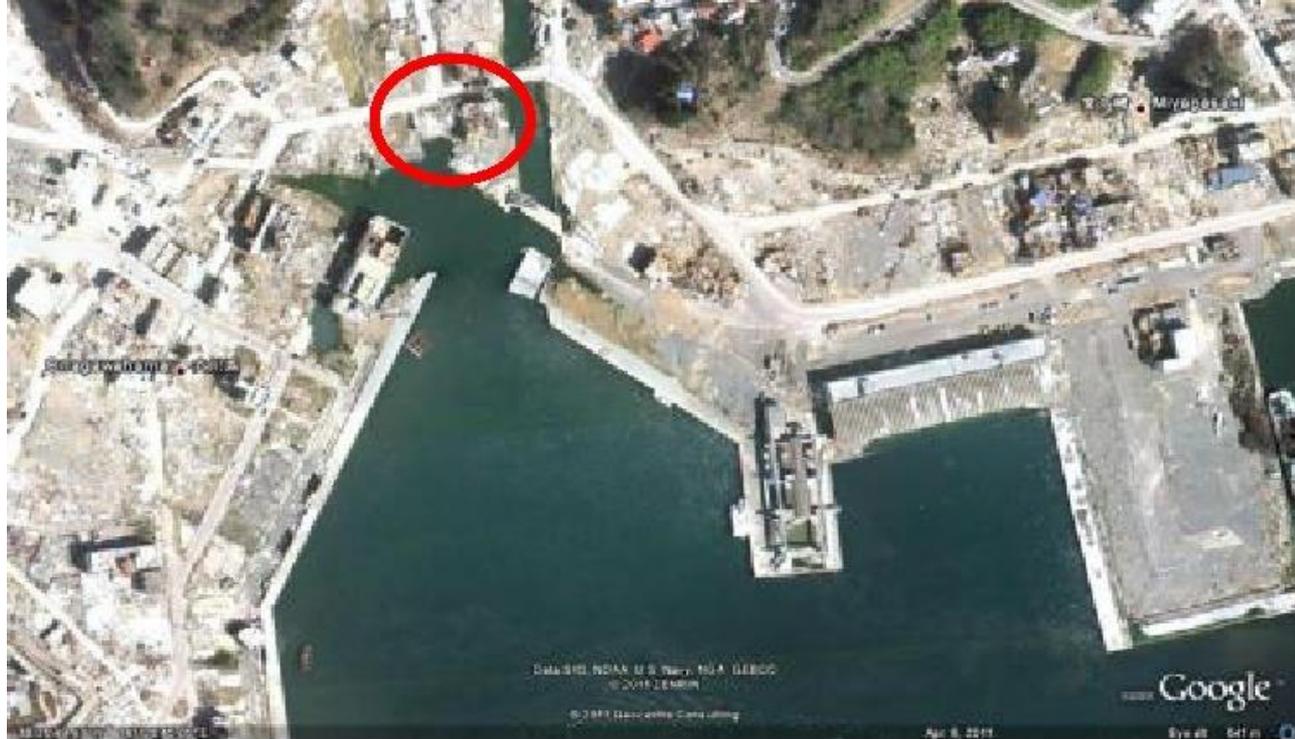
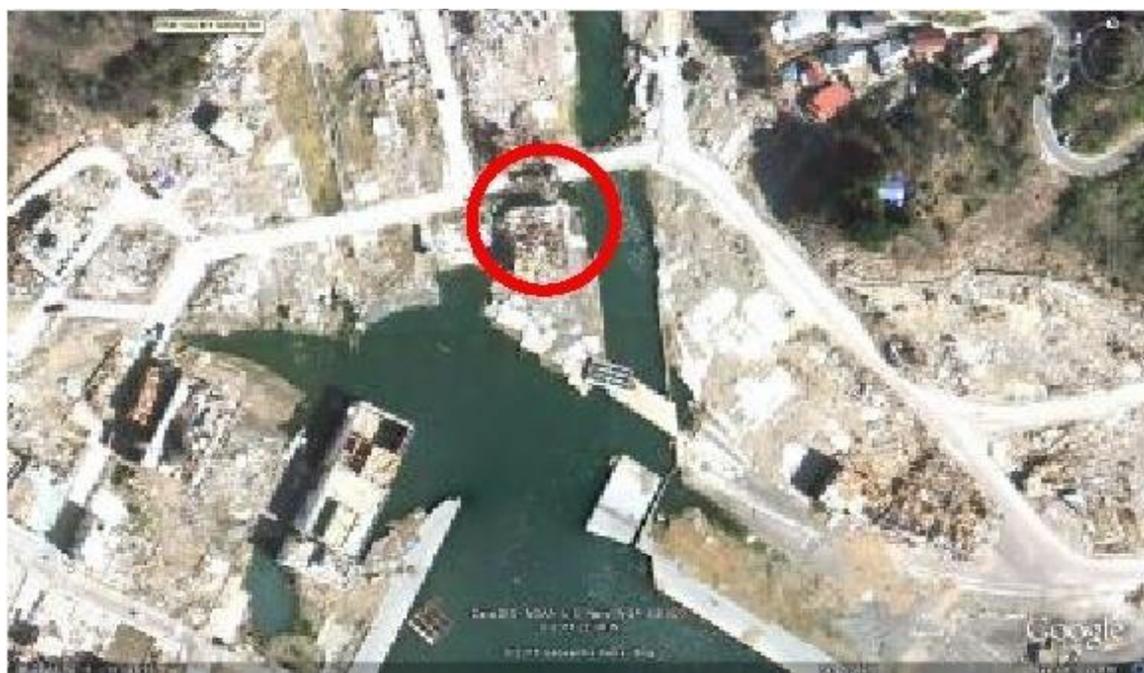
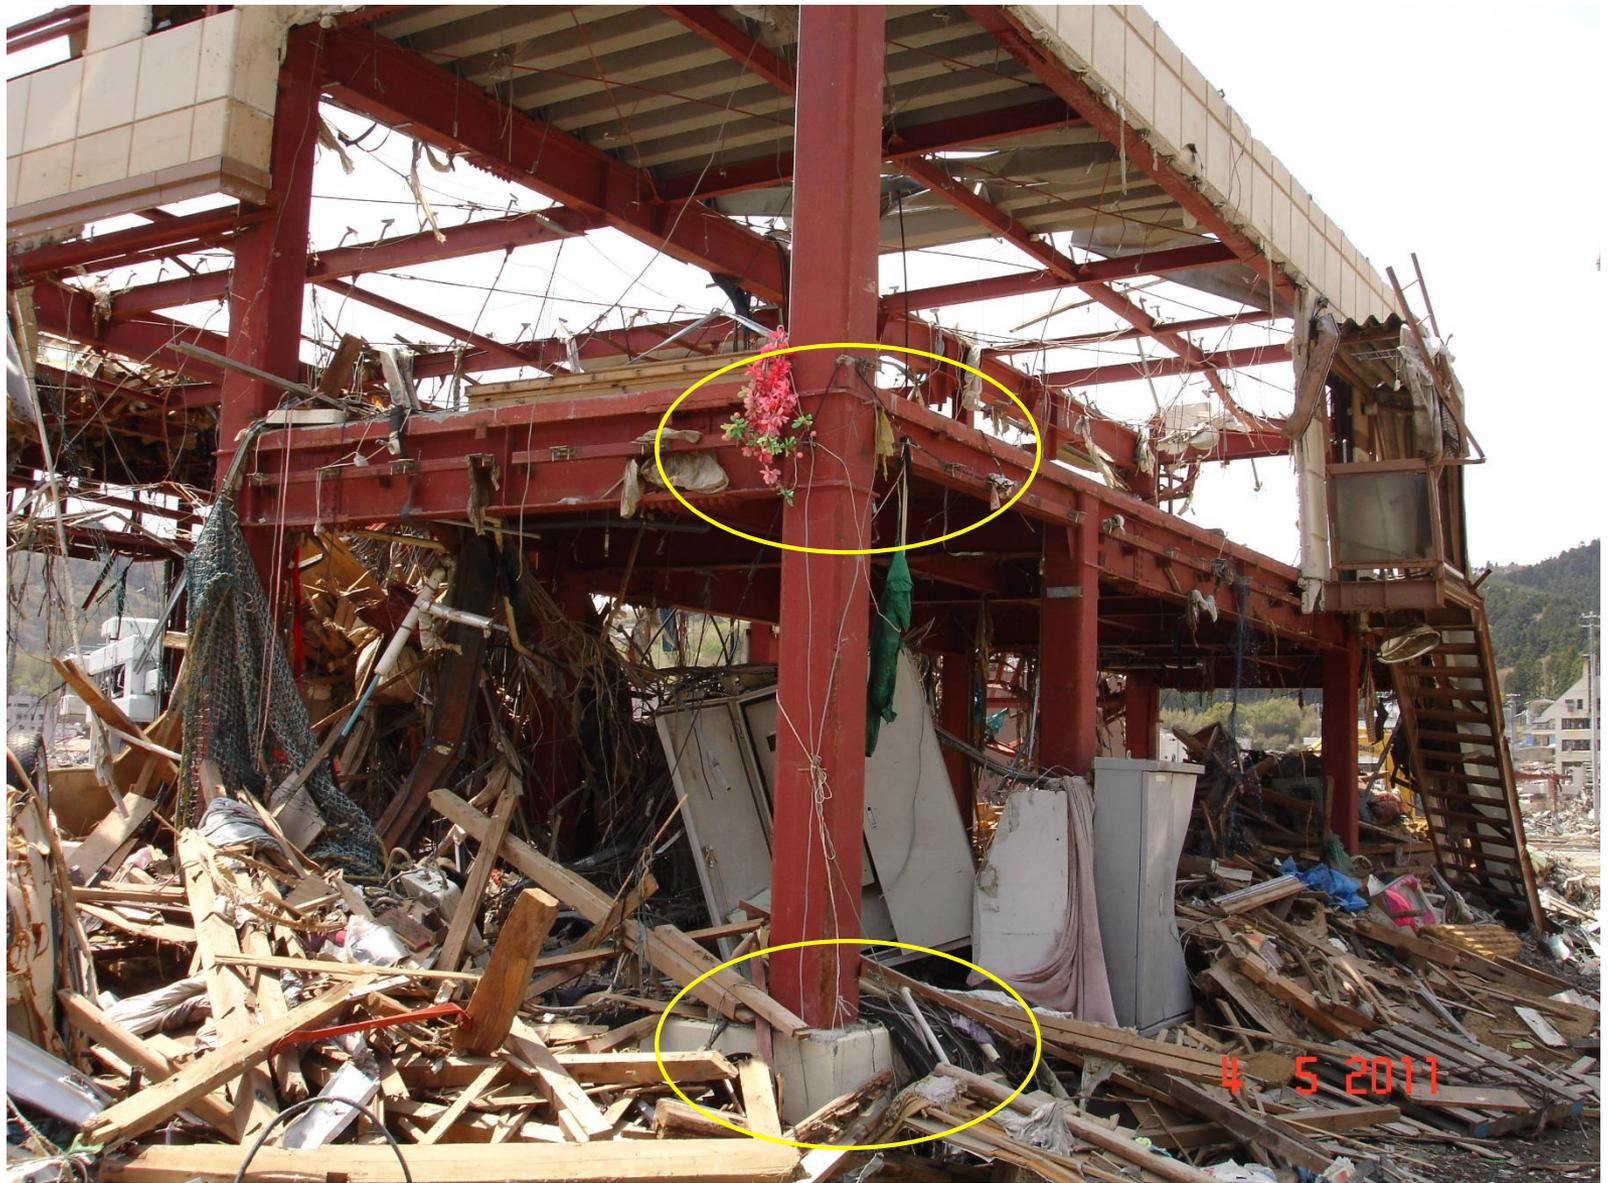
**Steel structure just near by the coast of Onagawa**

The exterior wall was lost;  
Steel structure could withstand large tsunami forces

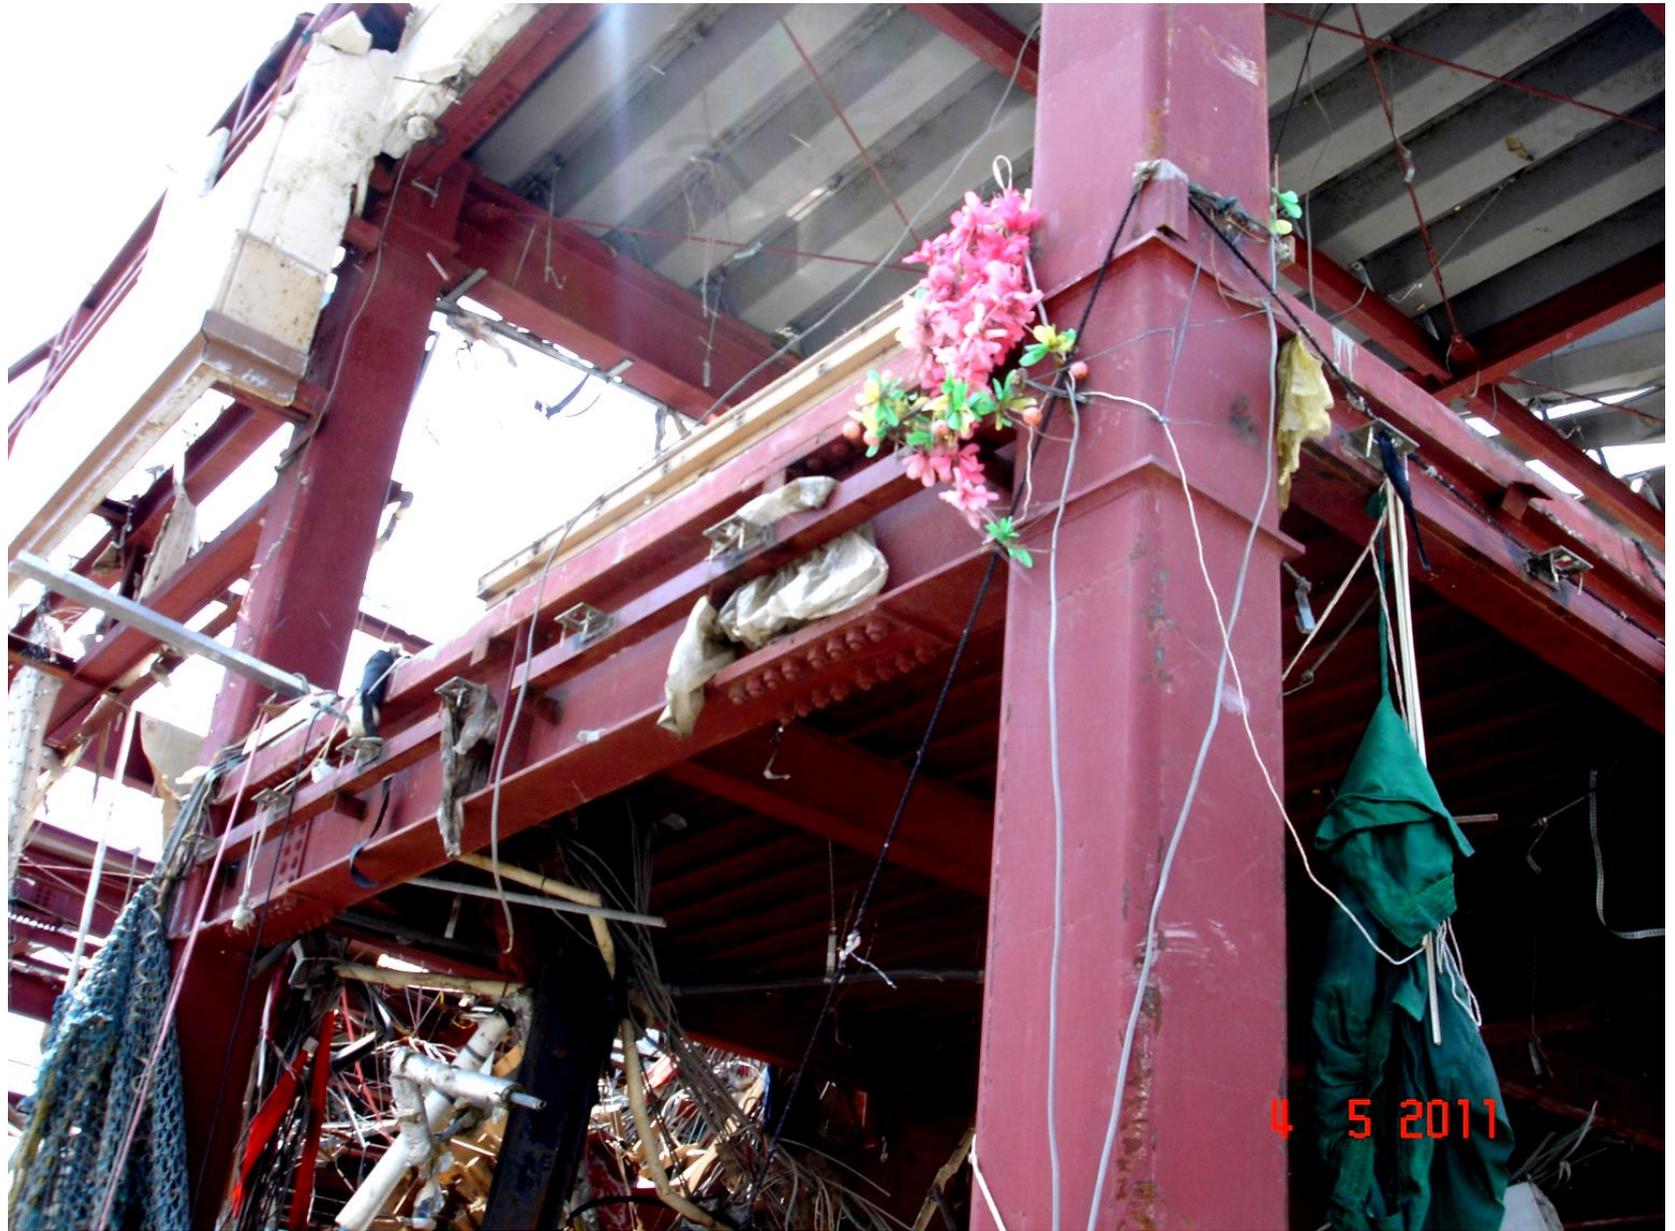
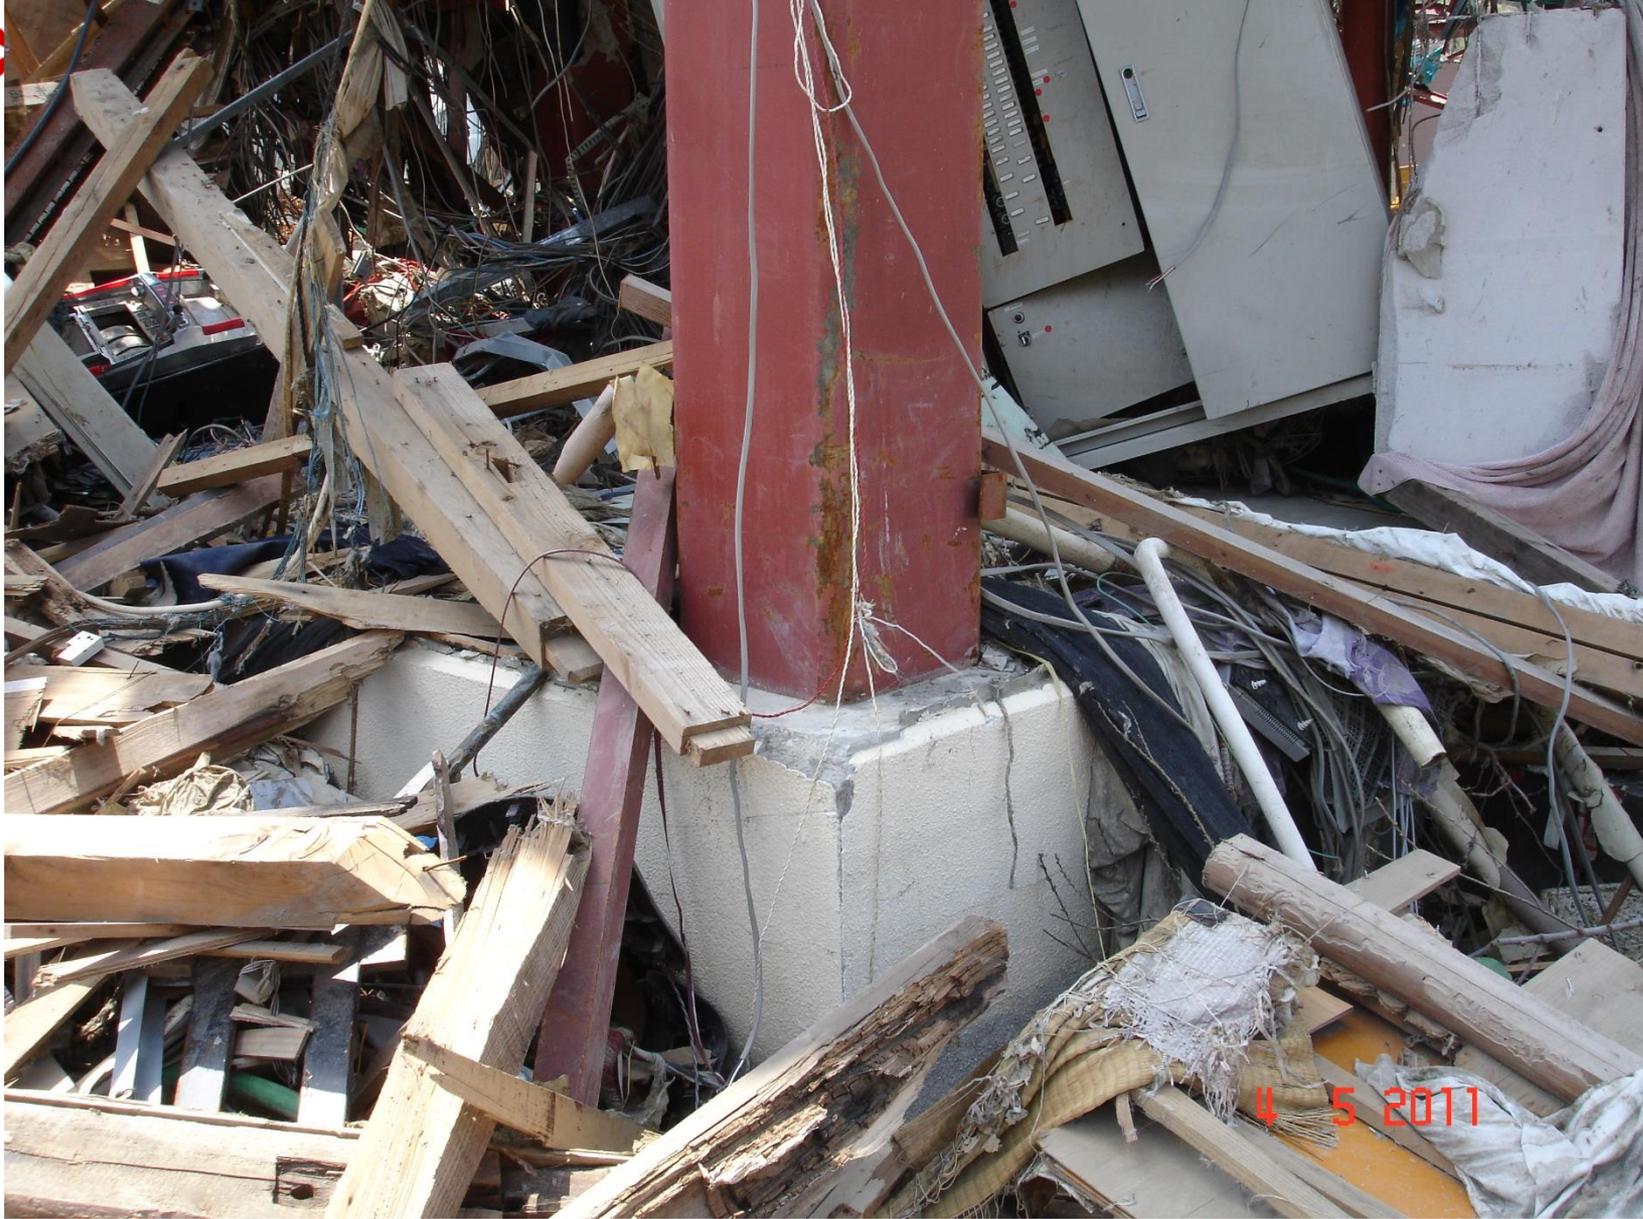
**The strength of the column base seemed to play a key role in collapse prevention against the tsunami**
